Appendix D

Cable System Condition History

1.0 Introduction

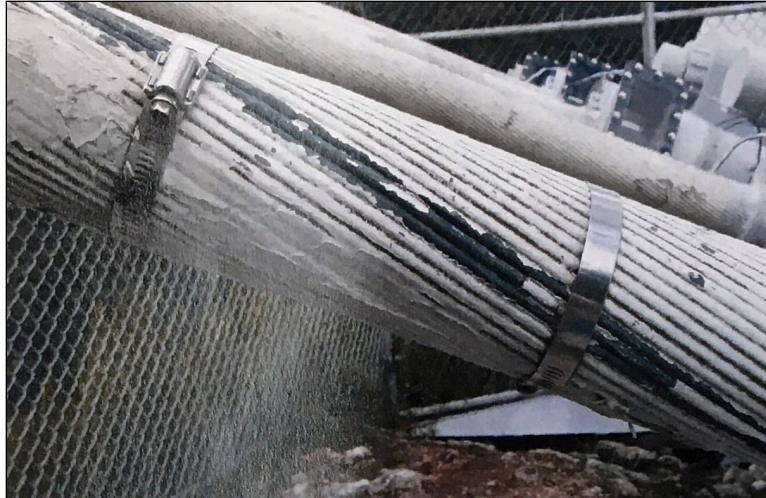
Figure 4: Original backstay B12-5 near anchor in 2003. Clamps and missing paint indicate a broken wire. Paint is also cracked between other wires (*photo: Ammann & Whitney¹*).

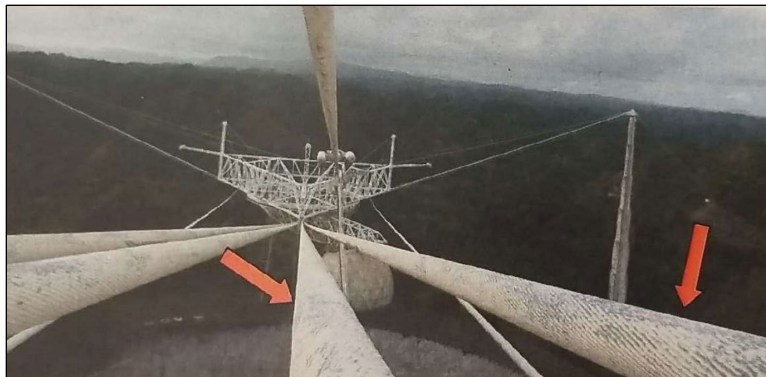
2011 structural inspection report ^E	<p><u>Original backstays</u>: "The backstay paint condition was rated as poor by the 2003 survey and there is no change in status."</p> <p><u>Auxiliary backstays</u>: "The paint condition on the auxiliary cables was rated as good in the 2003 survey, and there is no change in status."</p> <p><u>Original mains</u>: "The main cable paint condition was rated as poor in the 2003 survey, and there is no change in status."</p> <p><u>Auxiliary mains</u>: "The paint condition of the auxiliary main cables was rated as good in the 2003 report and there is no change in status."</p> <p><u>Recommendation</u>: "As a priority, all of the original project cables should be painted."</p>	The cables were subject to close-up inspection at the cable ends, and inspected with binoculars from the ground, the platform and the top of the towers.

Figure 5: Paint deterioration on original mains at top of Tower 12 in 2011 (*photo: Ammann & Whitney²*).

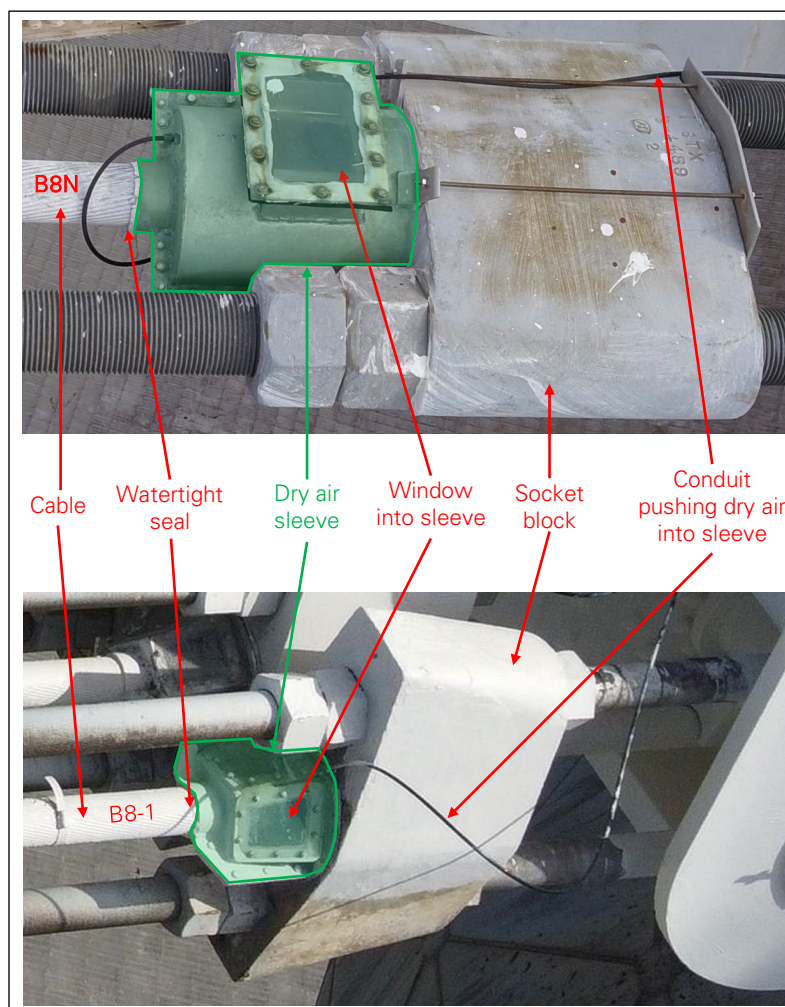
As an alternative to sealing off the cable ends, AO implemented a moisture exclusion system that pushed dry air into the cable. As shown in Figure 6, the lower end of each cable was encased in an airtight sleeve just outside the cable socket, so dry air could be pushed into the sleeve and forced to enter the cable through the gaps between the wires near the socket. According to experiments

Figure 6: Moisture exclusion system on auxiliary main (B8N, top) and original main (B8-1, bottom) sockets in 2020
(photos: NAIC Arecibo Observatory, a facility of the NSF).

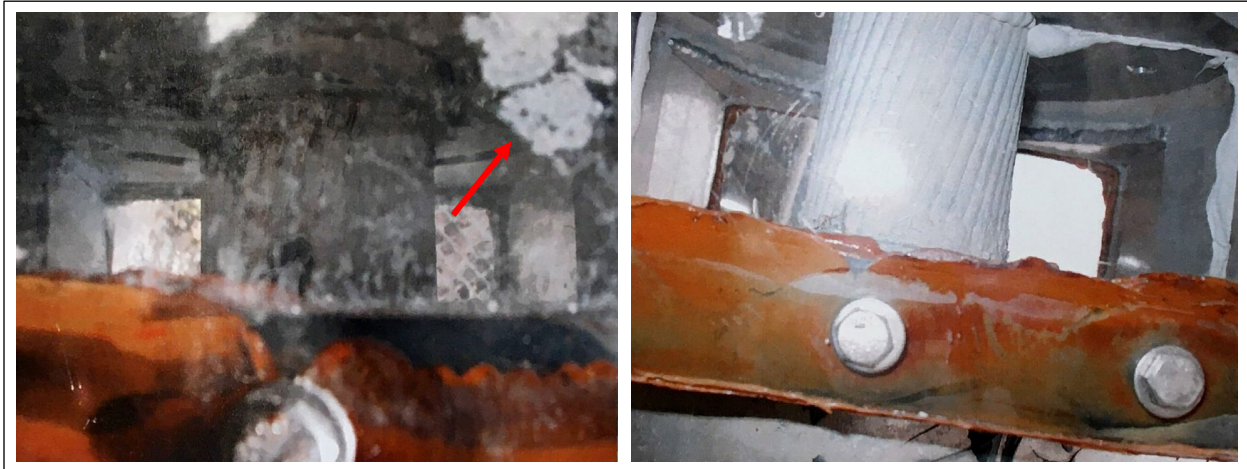
The maintenance and inspection documents include several reports, beginning in 2002, of condensation inside the dry air sleeves of some of the auxiliary cables (Figure 7 and Figure 8). The cause, extent and duration of the problem are not precisely known, although it affected backstays and main cables and persisted until at least 2011.

Figure 7: Condensation inside dry air sleeve of cable B4S (left) compared to typical condition of dry air sleeves (right) in 2003 (photos: Amman & Whitney⁴).

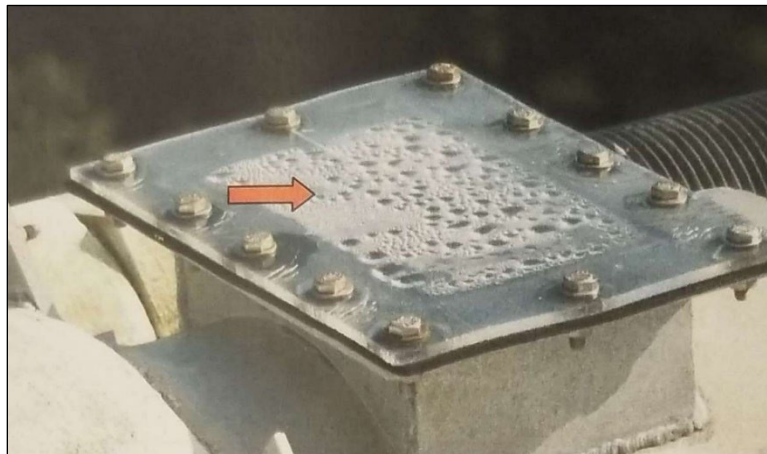
Figure 8: Condensation inside dry air sleeve on cable M4N in 2011 (photos: Amman & Whitney⁵).

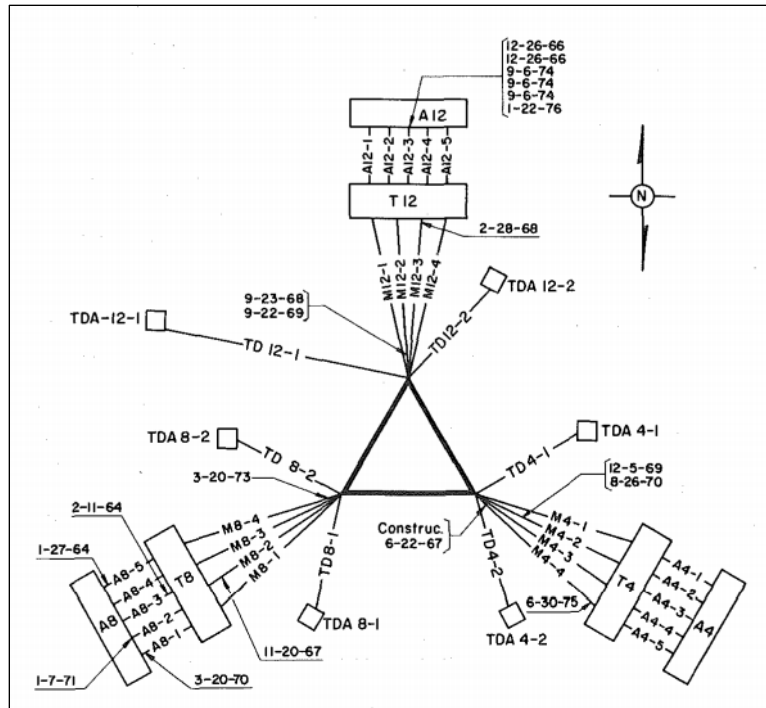
A map of the wire breaks discovered up to 1983 was published in a paper by Phoenix, Johnson and McGuire (Figure 9), with the map showing 20 known wire breaks. Six of these breaks were located at the ground end of cable B12-3, leading AO to replace that cable in 1981 as a precaution (Appendix C). According to the AO maintenance records and correspondence, eight additional wire breaks were discovered between 1982 and 2003 (Figure 10). The only new breaks on record after 2003 are located near the M8-4 cable splice: AW observed three breaks during a 2011 inspection, and nine additional breaks when re-inspecting the structure after a significant earthquake in January 2014 (Figure 11). As a precaution, a bypass was installed over the segment of cable with 12 breaks (Appendix C).

Figure 9: 1986 map of wire breaks (image: Phoenix, Johnson, and McGuire⁶).

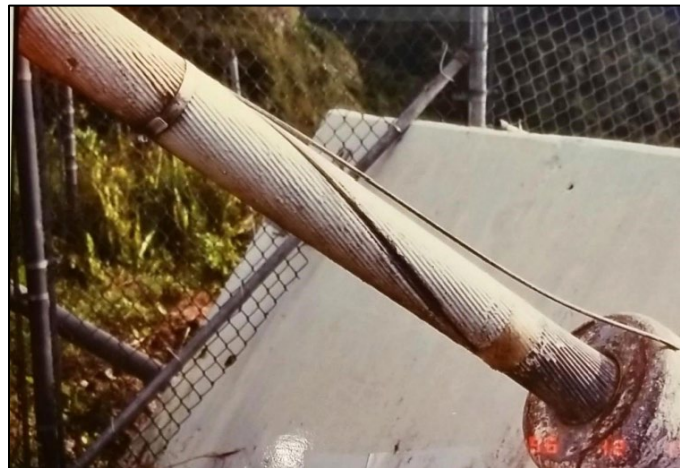
Figure 10: Wire break at ground end on B4-1 discovered on December 12, 1996 (photo: NAIC Arecibo Observatory, a facility of the NSF).

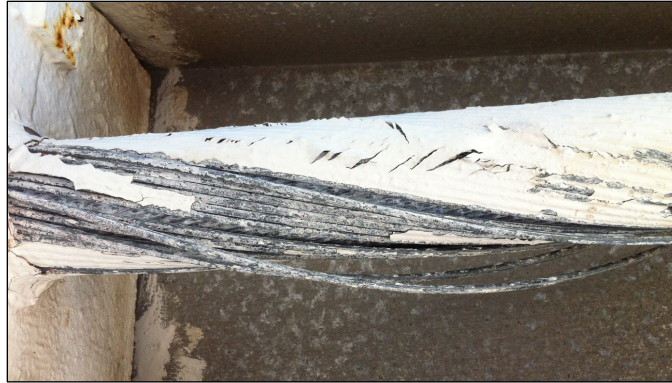
Figure 11: Multiple wire breaks near M8-4 splice discovered on January 14, 2014
(photo: NAIC Arecibo Observatory, a facility of the NSF).

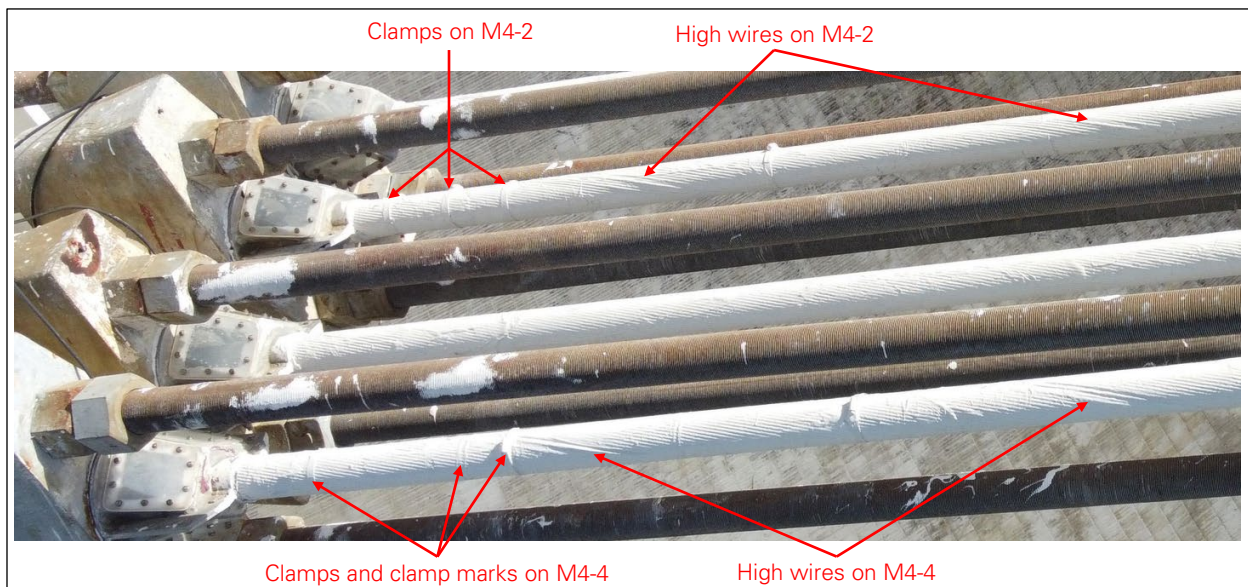
Figure 12: Evidence of past wire breaks at platform end of M4 cables
(photo: NAIC Arecibo Observatory, a facility of the NSF).

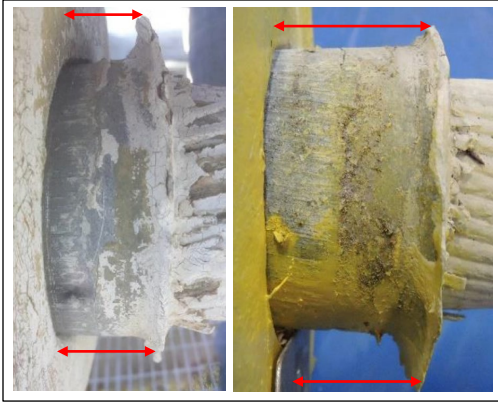
In this report, the *cable slip* refers to the distance that a cable end shifted with respect to its socket. In zinc-filled spelter sockets, the cable slip is typically measurable as the length of zinc extruded out of the socket (Figure 16).

Before breaking free on August 8, 2020, the end of cable M4N at the top of Tower 4 had slipped by more than one inch from its socket. This one-inch slip is approximately one-third of the cable's diameter and significantly more than typically observed in structural cables terminated with zinc-filled spelter sockets. We reviewed the telescope's maintenance and inspection records, as well as photographs, provided by AO to determine the history, extent, and severity of cable slip in the telescope structure. The available information is presented in this section.

Figure 16: Cable slip at socket M4N_T (left) and B12W_G (right)
(photos: NAIC Arecibo Observatory, a facility of the NSF).

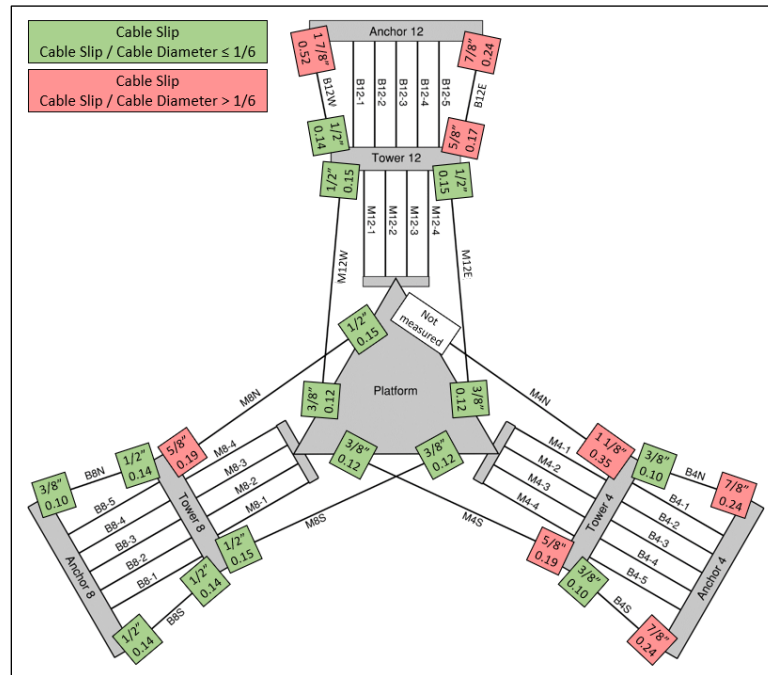
A map of the auxiliary cable slips at the time of collapse is provided in Figure 17. To determine the cable slips, we reviewed photographs taken in 2020 before the collapse and, when possible, took measurements on the sockets recovered after the collapse. The collapse does not appear to have significantly increased any of the cable slips.

The map indicates the ratio of the cable slip to the cable diameter, and sockets are flagged when this ratio is greater than one sixth. The one-sixth limit is based on the AASHTO M277⁷ standard for testing wire ropes used in moveable bridges. Because the telescope's auxiliary cables had been loaded for 25 years when the structure collapsed and may therefore have experienced long-term creep effects that do not occur during short load tests, the comparison of the Arecibo cable slips to the one sixth limit is for reference only.

Figure 17: Cable slip at auxiliary sockets before collapse.

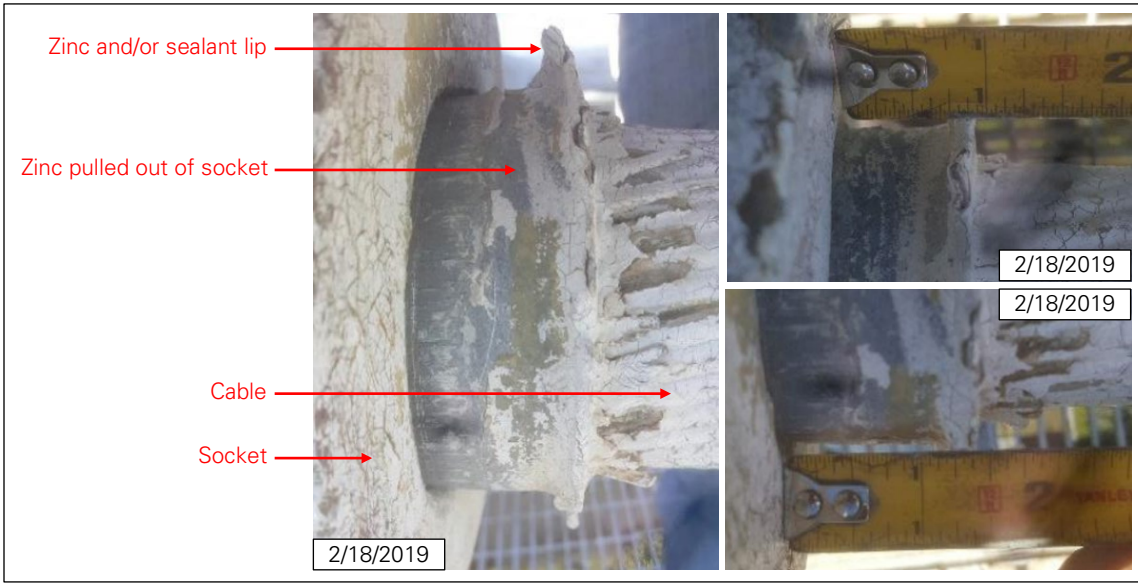
Socket M4N_T

Figure 18: Cable slip at socket M4N_T. As seen from the north side (left) and measured on north (top right) and south (bottom right) sides of socket (photos: NAIC Arecibo Observatory, a facility of the NSF).

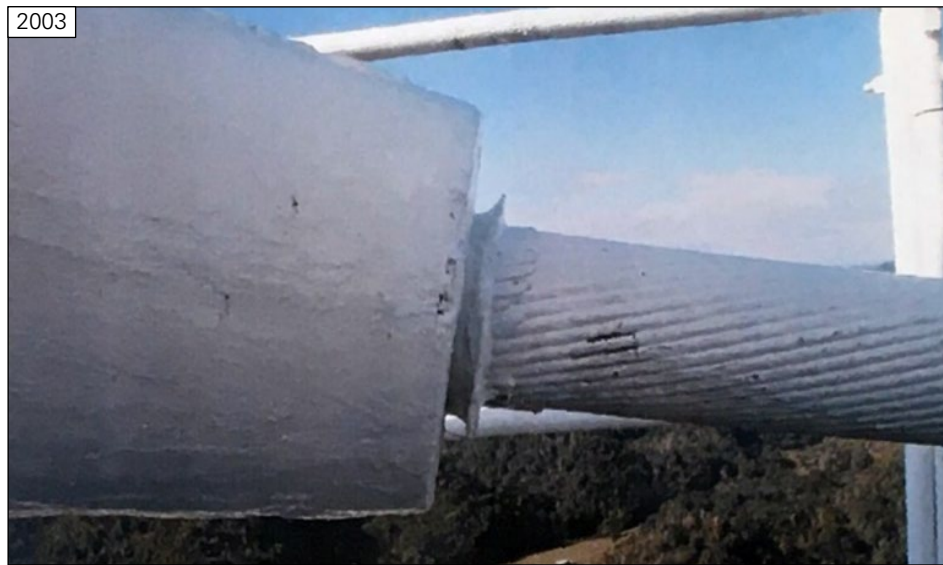
Socket M4S_T

Figure 19: Cable slip at socket M4S_T
(photo: Ammann & Whitney⁸).

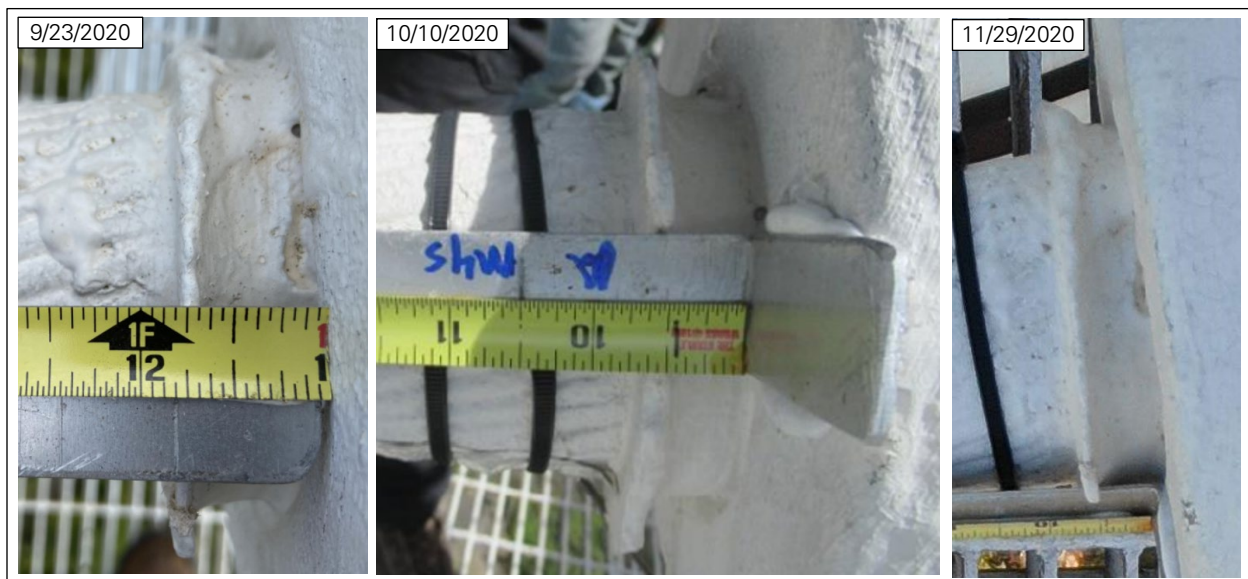
Figure 20: Cable slip at socket M4S_T
(left and center photos: WJE⁹; right photo: NAIC Arecibo Observatory, a facility of the NSF).

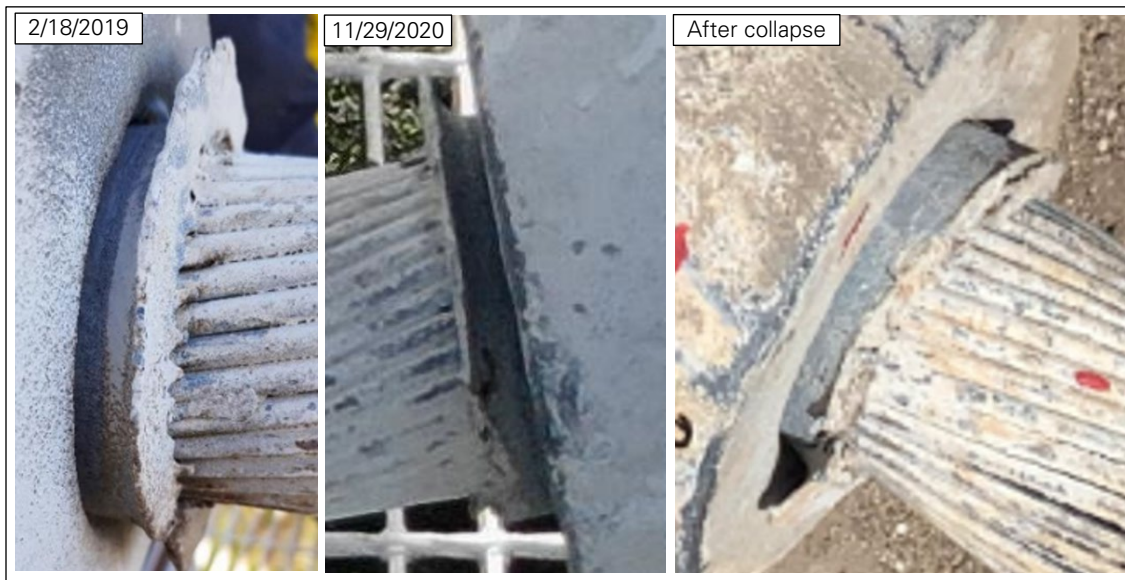
Socket M8N_T

Figure 21: Cable slip at socket M8N_T
(left and center photos: NAIC Arecibo Observatory, a facility of the NSF).

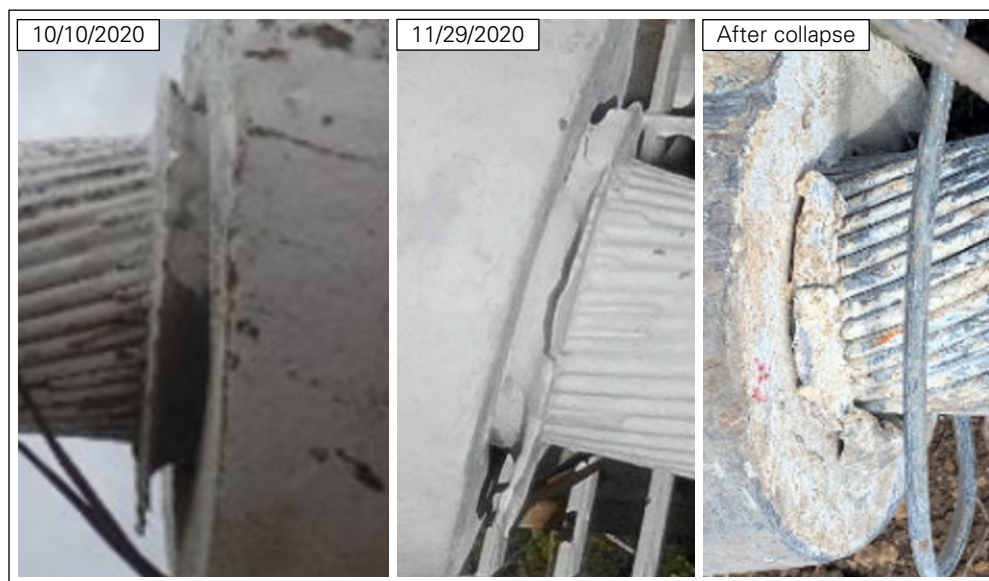
Socket M8S_T

Figure 22: Cable slip at socket M8S_T
(left photo: WJE¹⁰; center photo: NAIC Arecibo Observatory, a facility of the NSF).

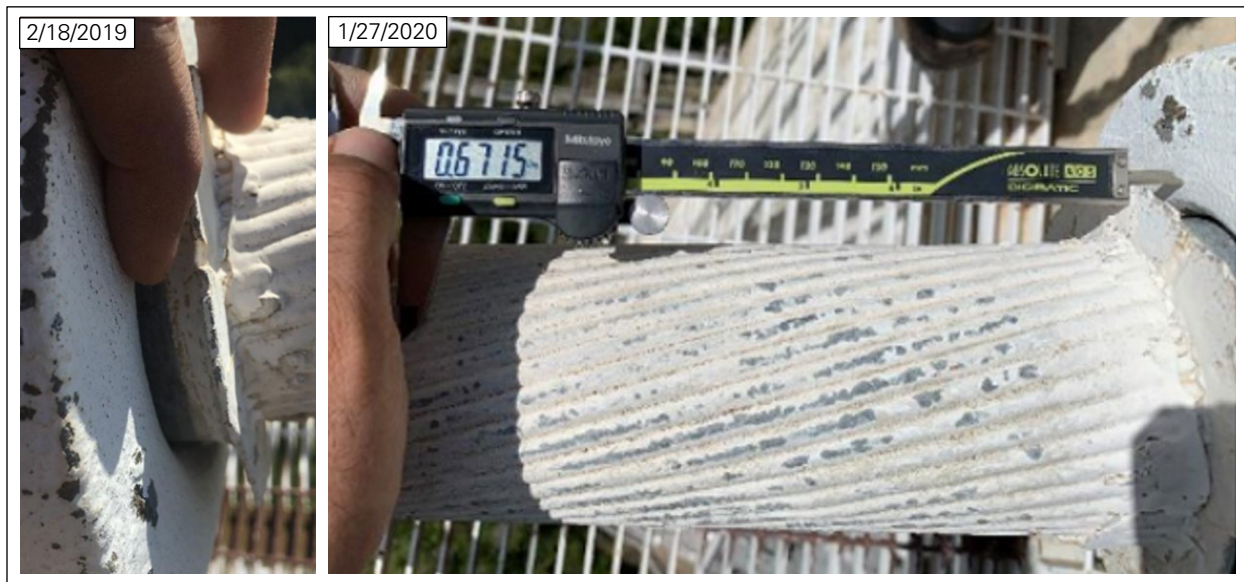
Socket M12E_T

Figure 23: Cable slip at socket M12E_T
(photos: NAIC Arecibo Observatory, a facility of the NSF).

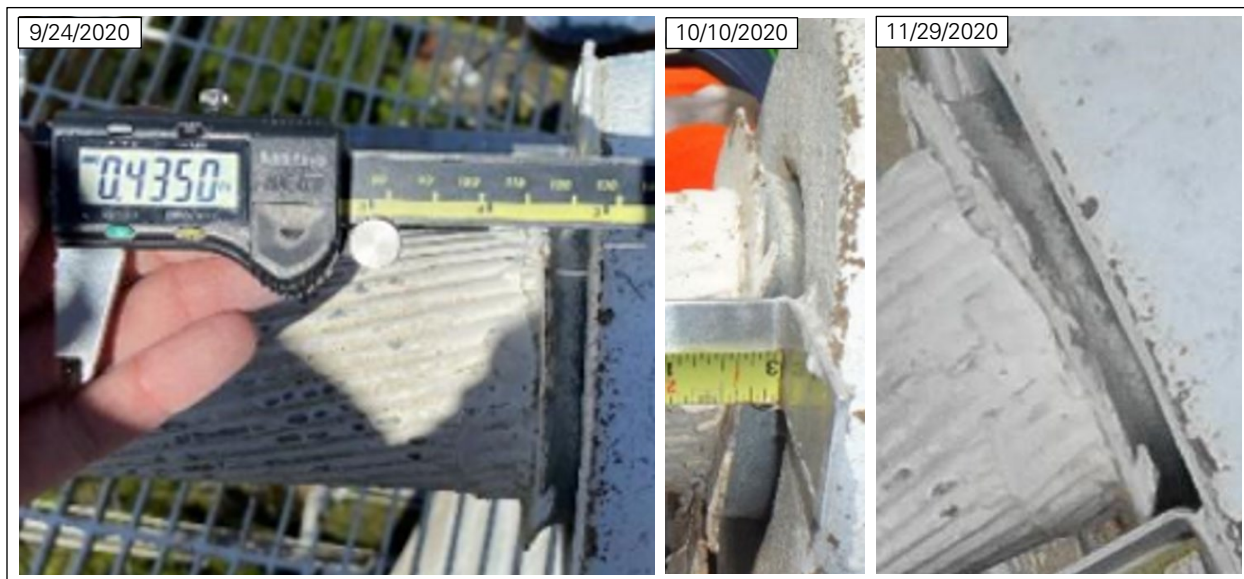
Figure 24: Cable slip at socket M12E_T
(left and center photos: WJE¹¹; right photo: NAIC Arecibo Observatory, a facility of the NSF).

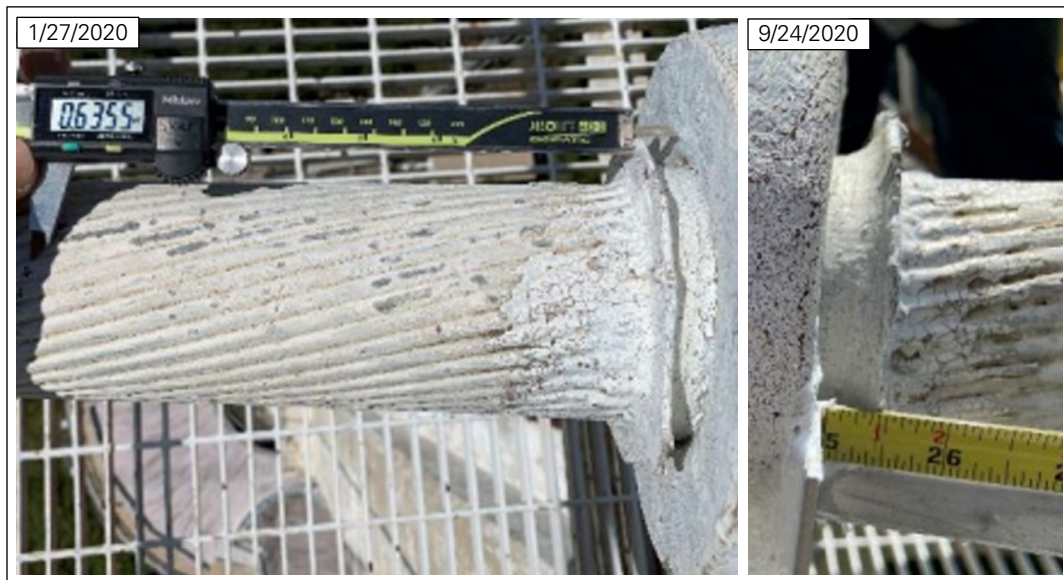
Socket M12W_T

Figure 25: Cable slip at socket M12W_T
(left photo: NAIC Arecibo Observatory, a facility of the NSF; right photo: WJE¹²).

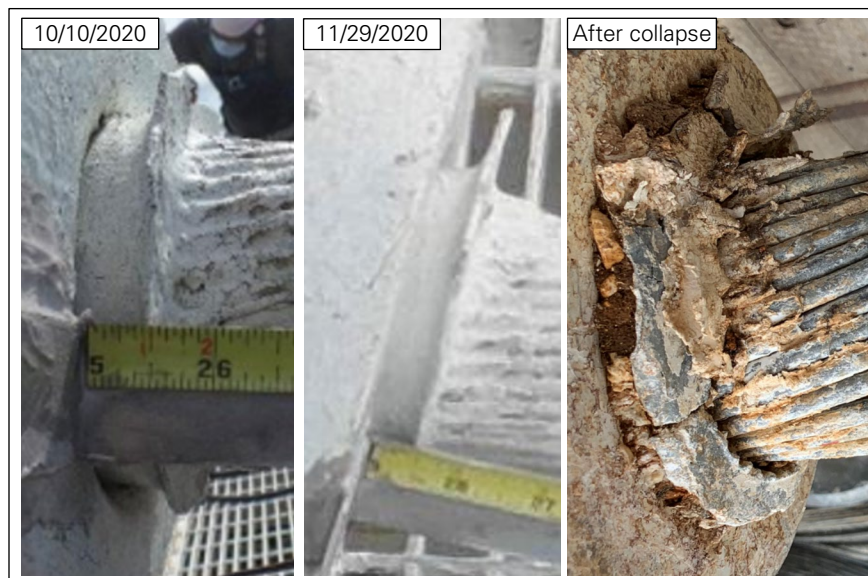
Figure 26: Cable slip at socket M12W_T
(left photo: WJE¹²; center photo: NAIC Arecibo Observatory, a facility of the NSF).

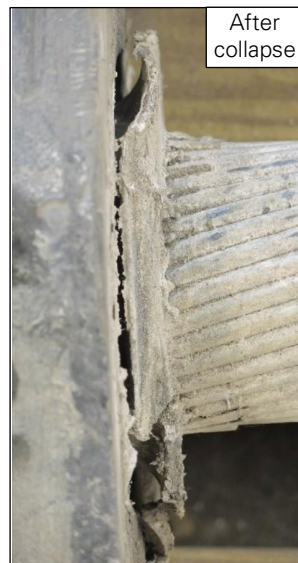
Socket M4S_P

Figure 27: Cable slip at socket M4S_P.

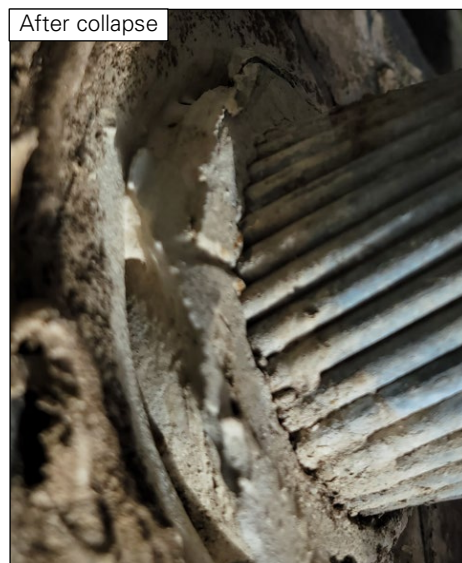
Socket M8N_P

Figure 28: Cable slip at socket M8N_P.

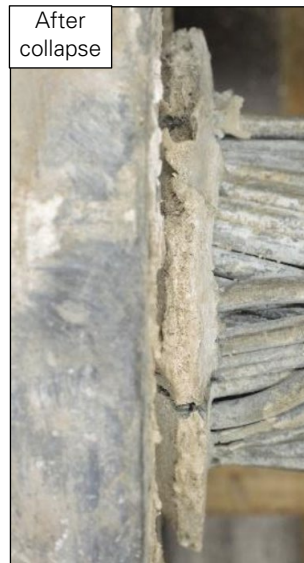
Socket M8S_P

Figure 29: Cable slip at socket M8S_P.

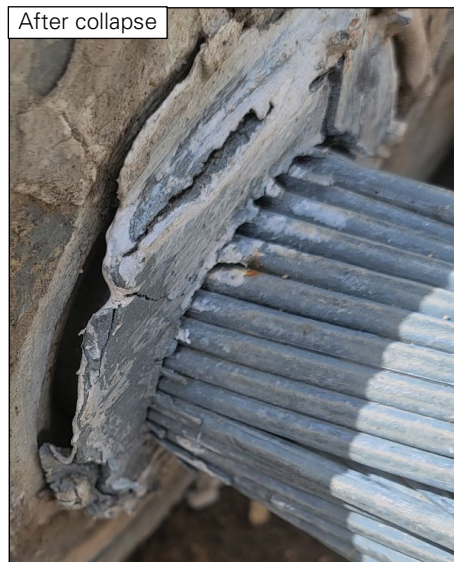
Socket M12E_P

Figure 30: Cable slip at socket M12E_P.

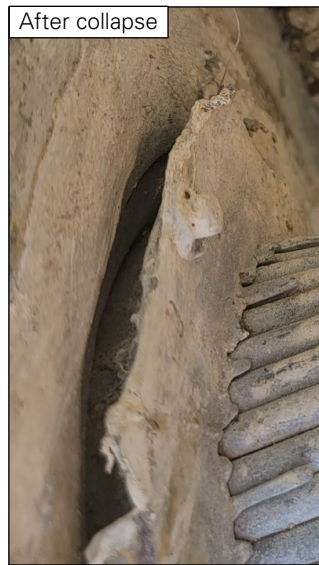
Socket M12W_P

Figure 31: Cable slip at socket M12W_P.

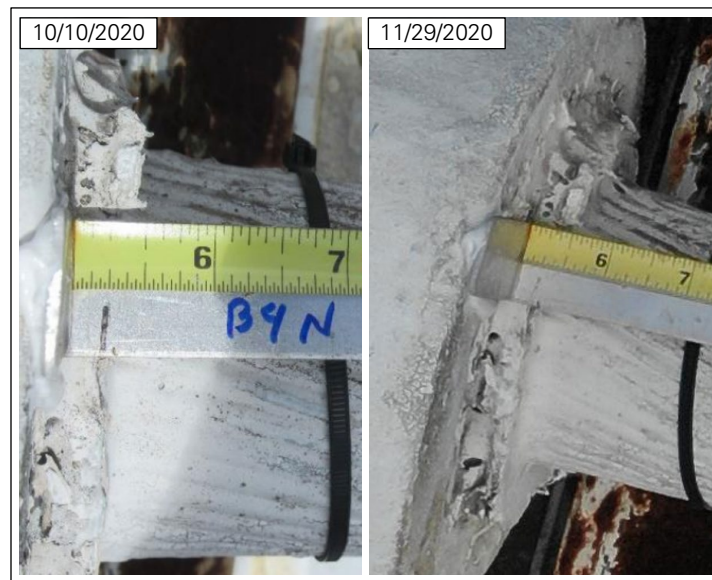
Socket B4N_T

Figure 32: Cable slip at socket B4N_T
(left photo: WJE¹³; right photo: NAIC Arecibo Observatory, a facility of the NSF).

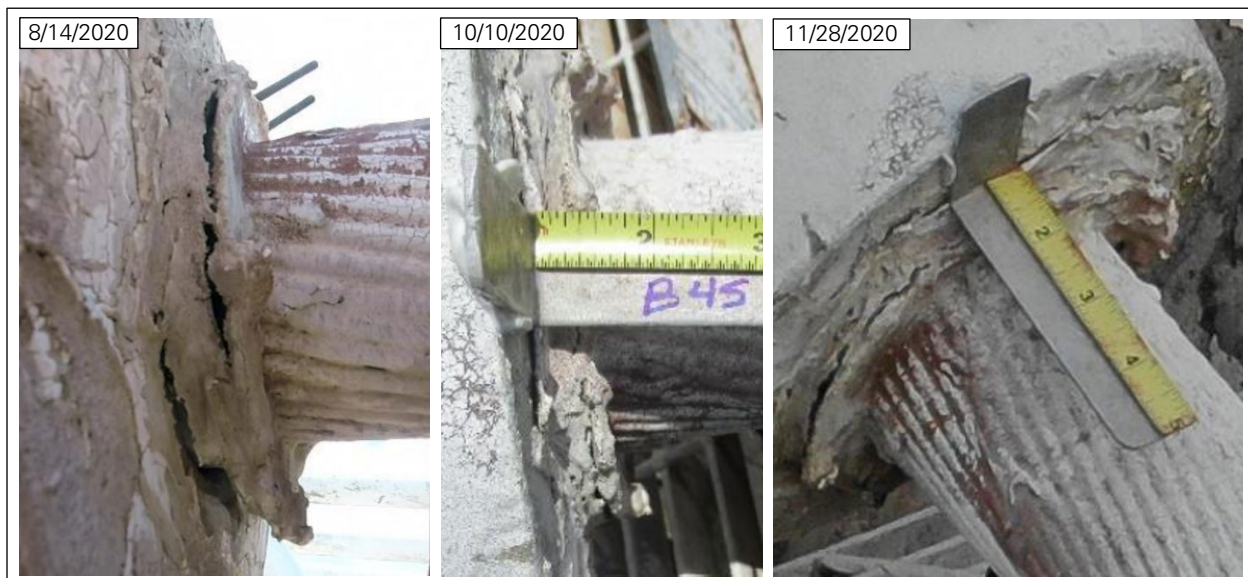
Socket B4S_T

Figure 33: Cable slip at socket B4S_T
(left and right photos: NAIC Arecibo Observatory, a facility of the NSF; center photo: WJE¹³).

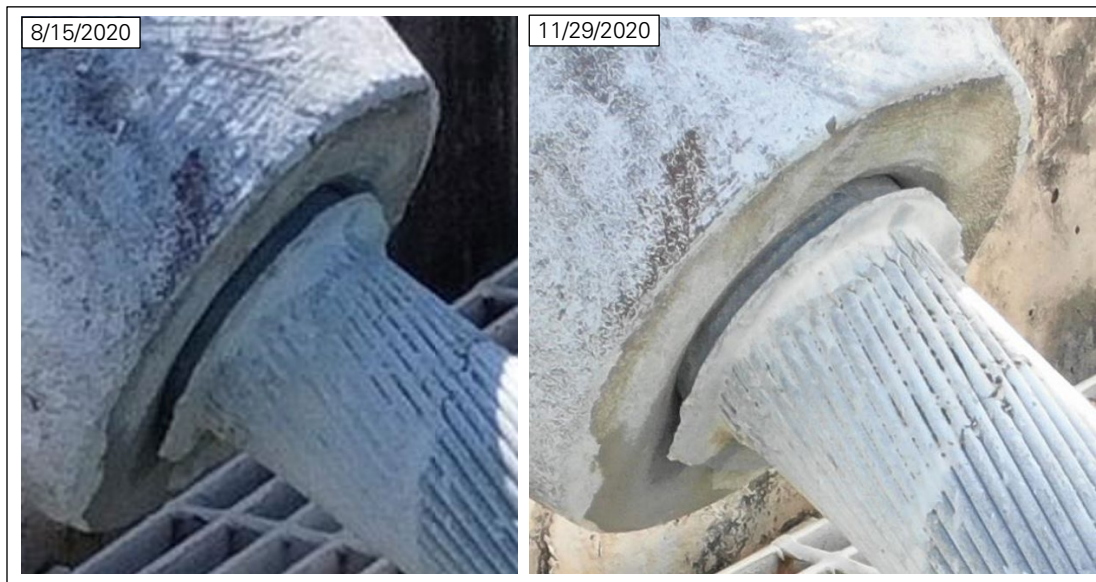
Socket B8N_T

Figure 34: Cable slip at socket B8N_T
(photos: NAIC Arecibo Observatory, a facility of the NSF).

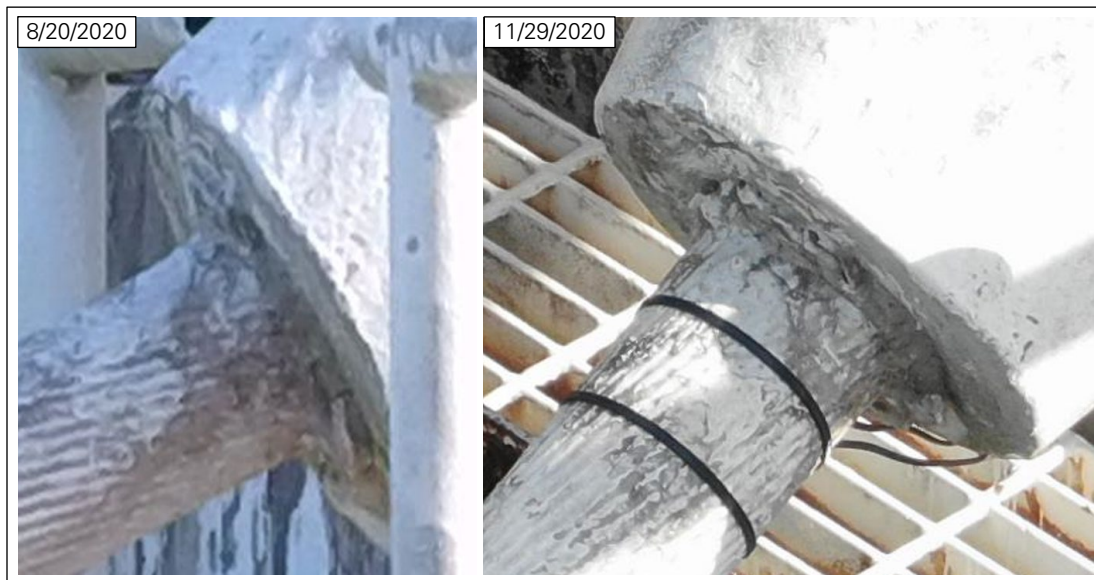
Socket B8S_T

Figure 35: Cable slip at socket B8S_T
(photos: NAIC Arecibo Observatory, a facility of the NSF).

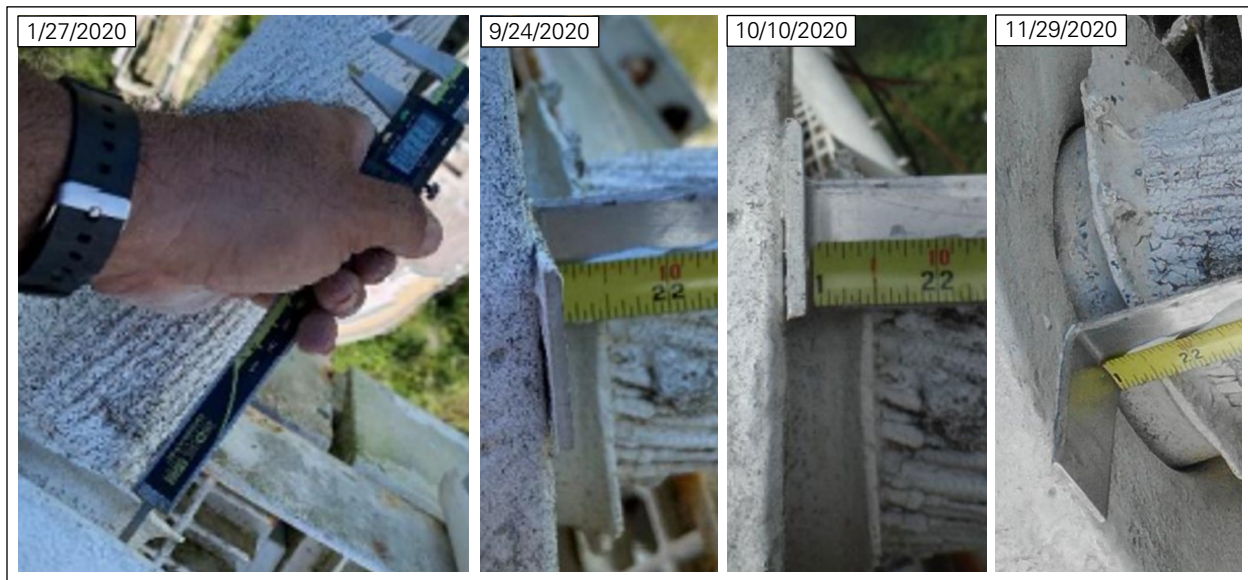
Socket B12E_T

Figure 36: Cable slip at socket B12E_T
(left and right photos: NAIC Arecibo Observatory, a facility of the NSF; center photos: WJE¹⁴).

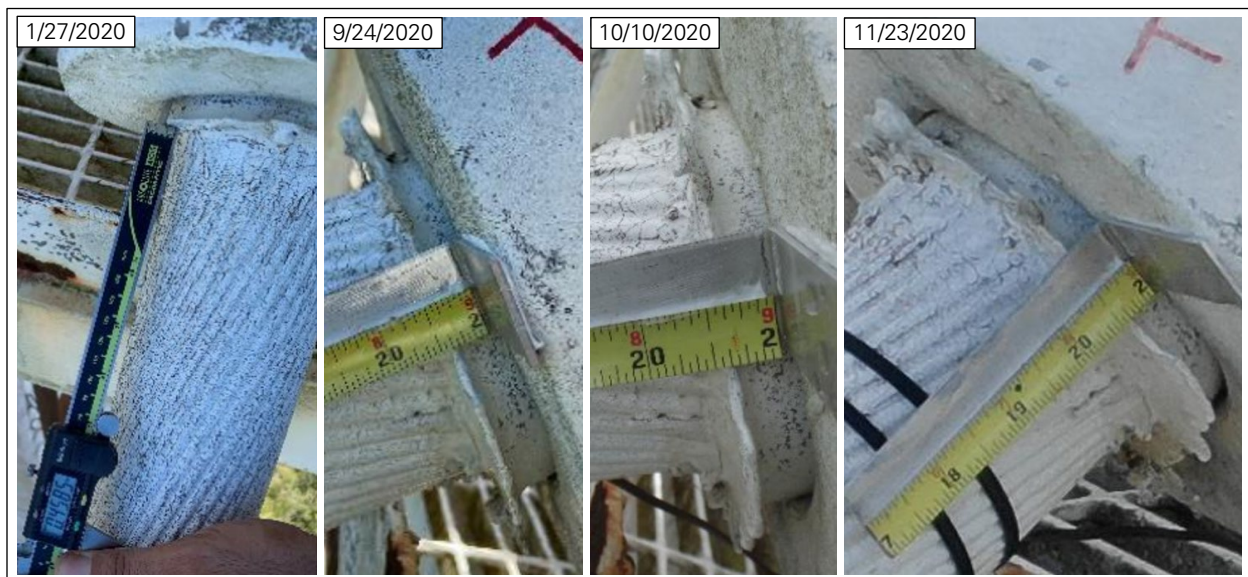
Socket B12W_T

Figure 37: Cable slip at socket B12W_T
(left and right photos: NAIC Arecibo Observatory, a facility of the NSF; center photos: WJE¹⁴).

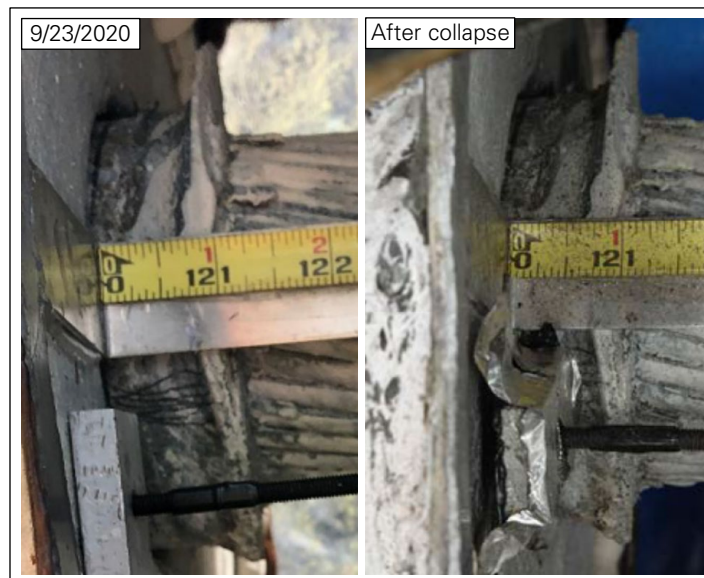
Socket B4N_G

Figure 38: Cable slip at socket B4N_G
(left photo: WJE¹⁵).

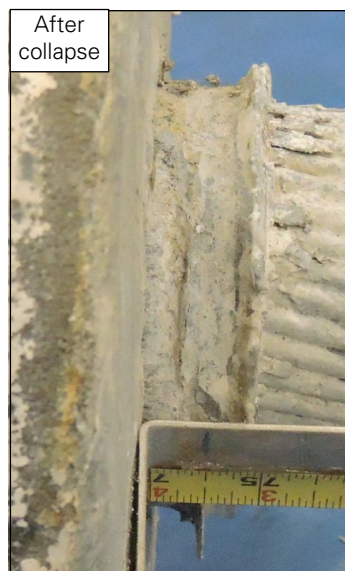
Socket B4S_G

Figure 39: Cable slip at socket B4S_G.

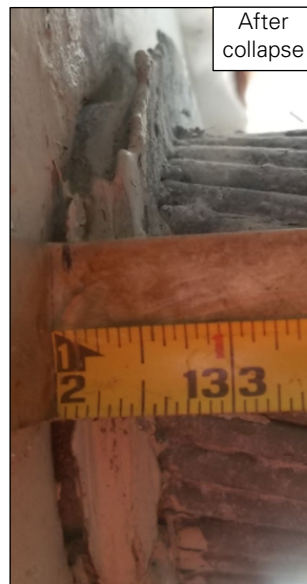
Socket B8N_G

Figure 40: Cable slip at socket B8N_G.

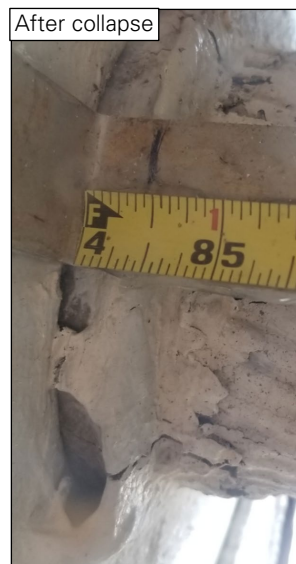
Socket B8S_G

Figure 41: Cable slip at socket B8S_G.

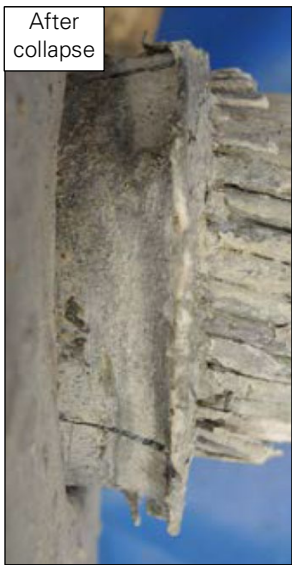
Socket B12E_G

Figure 42: Cable slip at socket B12E_G.

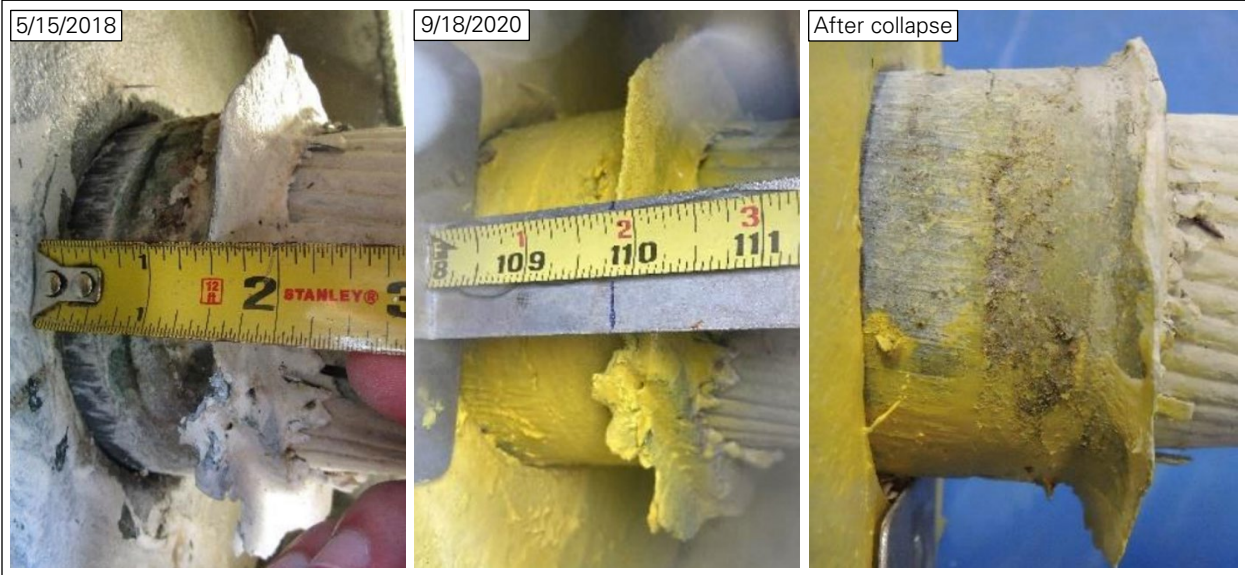
Socket B12W_G

Figure 43: Cable at socket B12W_G
(left and center photos: NAIC Arecibo Observatory, a facility of the NSF).
