Appendix M
Socket Laboratory Analysis

The cables of the telescope were terminated with zinc-filled spelter sockets, which are commonly used to connect large structural cables. The first and second cable failures in 2020 occurred near or within the sockets at the top of Tower 4, and significant cable slips were observed on other sockets before and after the cable failures. The behavior and failure of the sockets is therefore a focus of our investigation, and several sockets were recovered from the collapsed structure and analyzed in laboratories. The results of the laboratory analyses are presented in this appendix, which is organized by type of laboratory test.

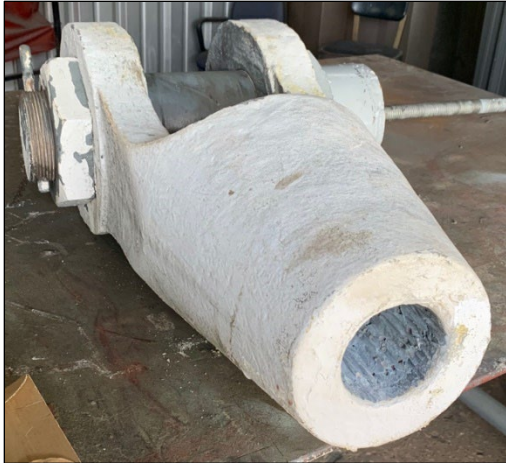
Socket M4N_T is where the first cable failure occurred on August 10, 2020. The socket was recovered from the top of tower 4 on September 23, 2020 (Figure 2), and shipped to Kennedy Space Center for analysis by the NASA Engineering and Safety Center (NESC) in collaboration with Wiss, Janney, Elstner Associates (WJE). The cable end that pulled out of M4N_T was recovered after the collapse (Figure 3) and also analyzed by WJE-NESC. The results of the WJE-NESC analysis are provided in a report,¹ and we include some of the report's findings in this appendix as additional data points when comparing the properties and behavior of different sockets.

Figure 2: Socket M4N_T recovered from Tower 4 after M4N failure (photo: WJE).

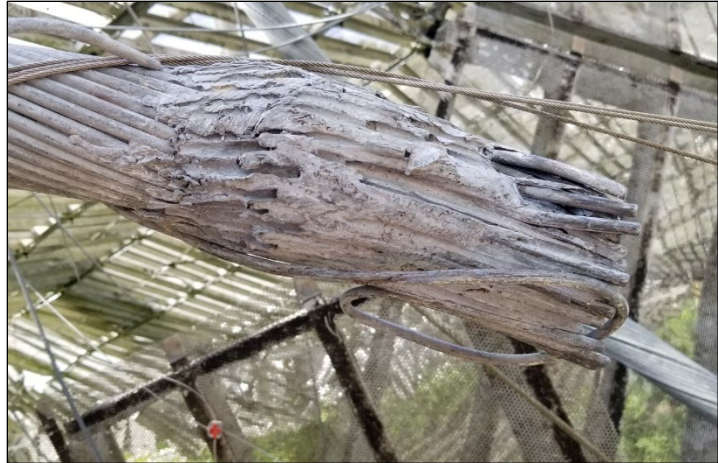
Figure 3: Cable end pulled out of socket M4N_T.

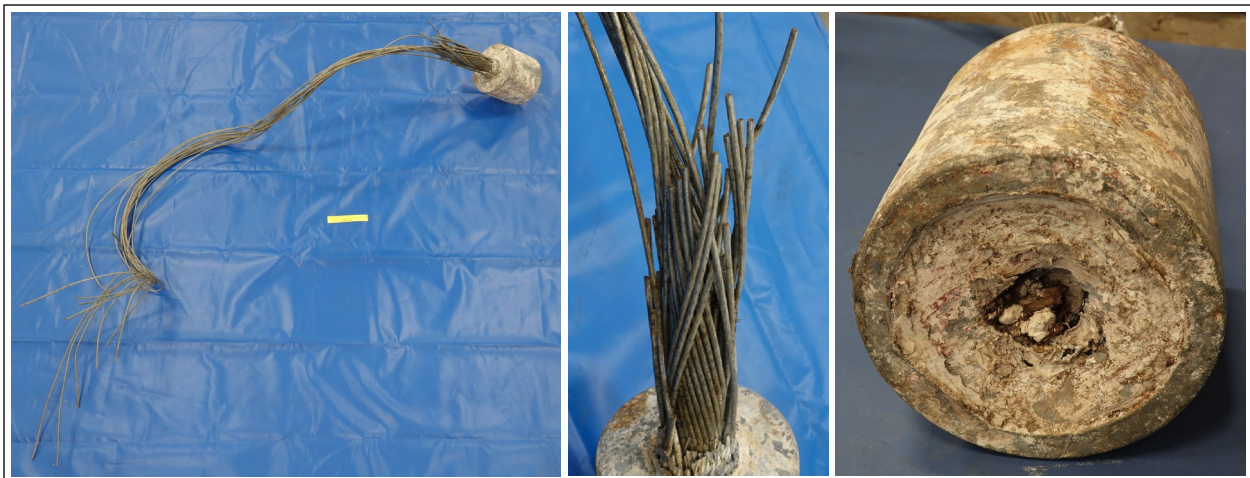
- M4-4_T (Figure 4), where the second cable failure occurred on November 6, 2020.
- B12W_G (Figure 5), which exhibits the largest cable slip (1.875 inch).
- M8N_T (Figure 6), which exhibits a relatively small cable slip (0.625 inch).
- B4N_G (Figure 7) and B4S_G (Figure 8), which exhibit intermediate cable slips (0.875 inch)

Figure 4: Socket M4-4_T (photos: Socotec).

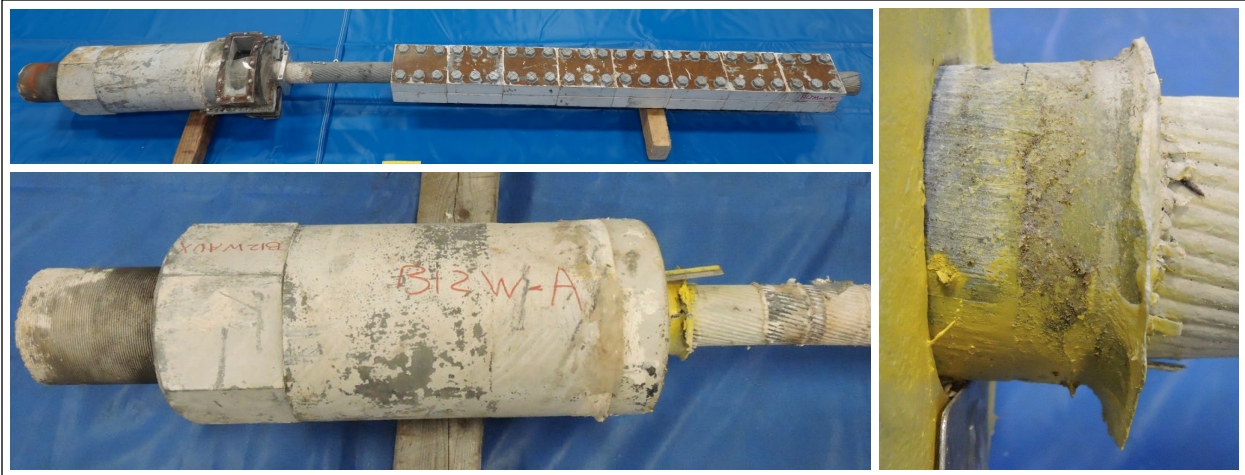
Figure 5: Socket B12W_G (photos: Socotec).

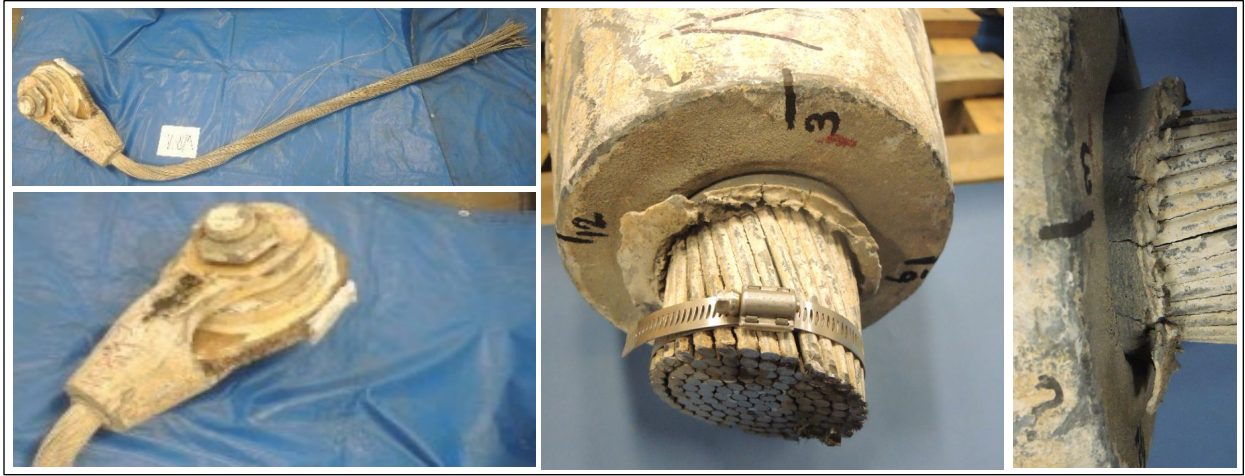
Figure 6: Socket M8N_T (photos: Socotec).

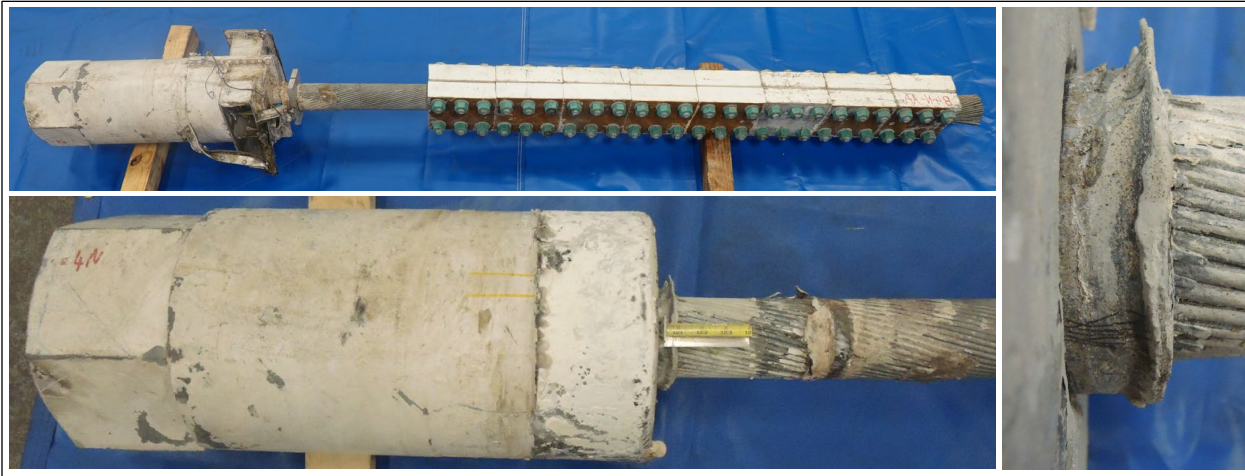
Figure 7: Socket B4N_G (photos: Socotec).

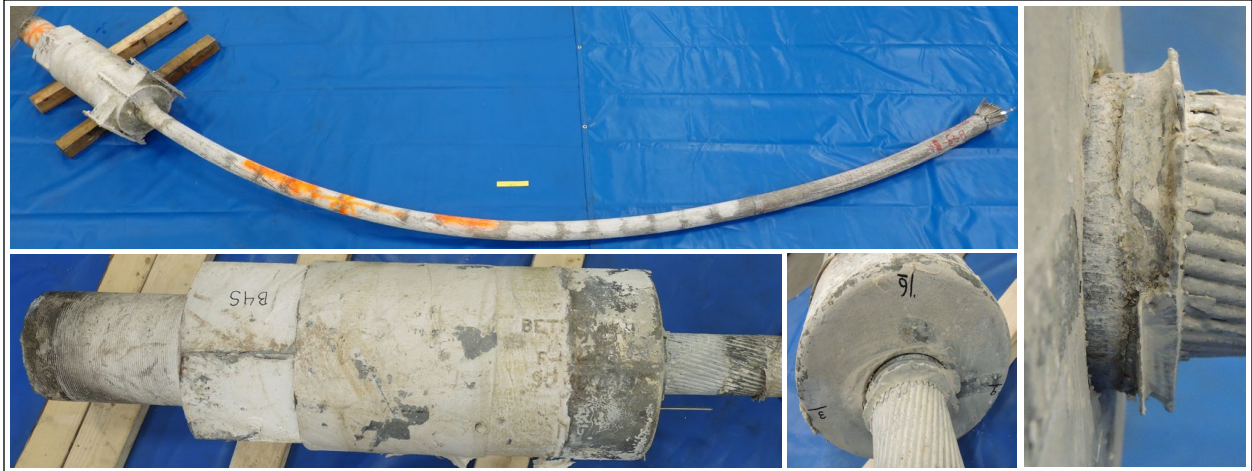
Figure 8: Socket B4S_G (photos: Socotec).

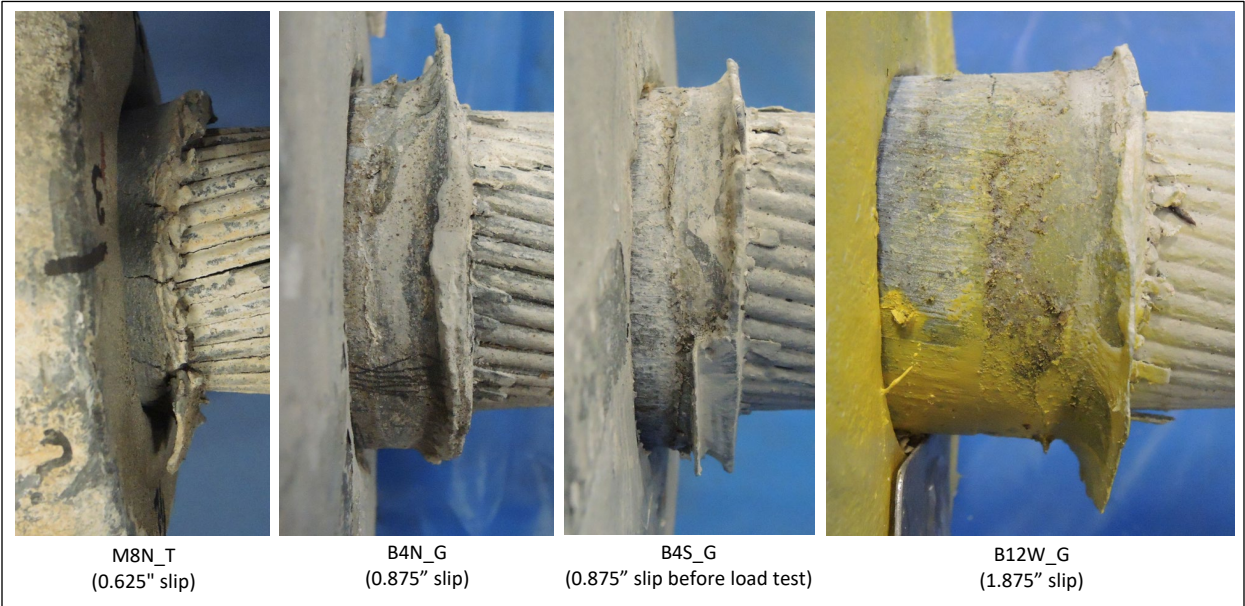
The cable slip is the distance that a cable end shifted with respect to its socket, as measured outside of the socket. As shown in Figure 9, the cable slip can be measured as the length of zinc that was extruded out of the socket as the cable slipped. The cable slips at the sockets considered in laboratory studies are summarized in Table 1.

Figure 9: Cable slips observed on four auxiliary sockets (photos: Socotec).

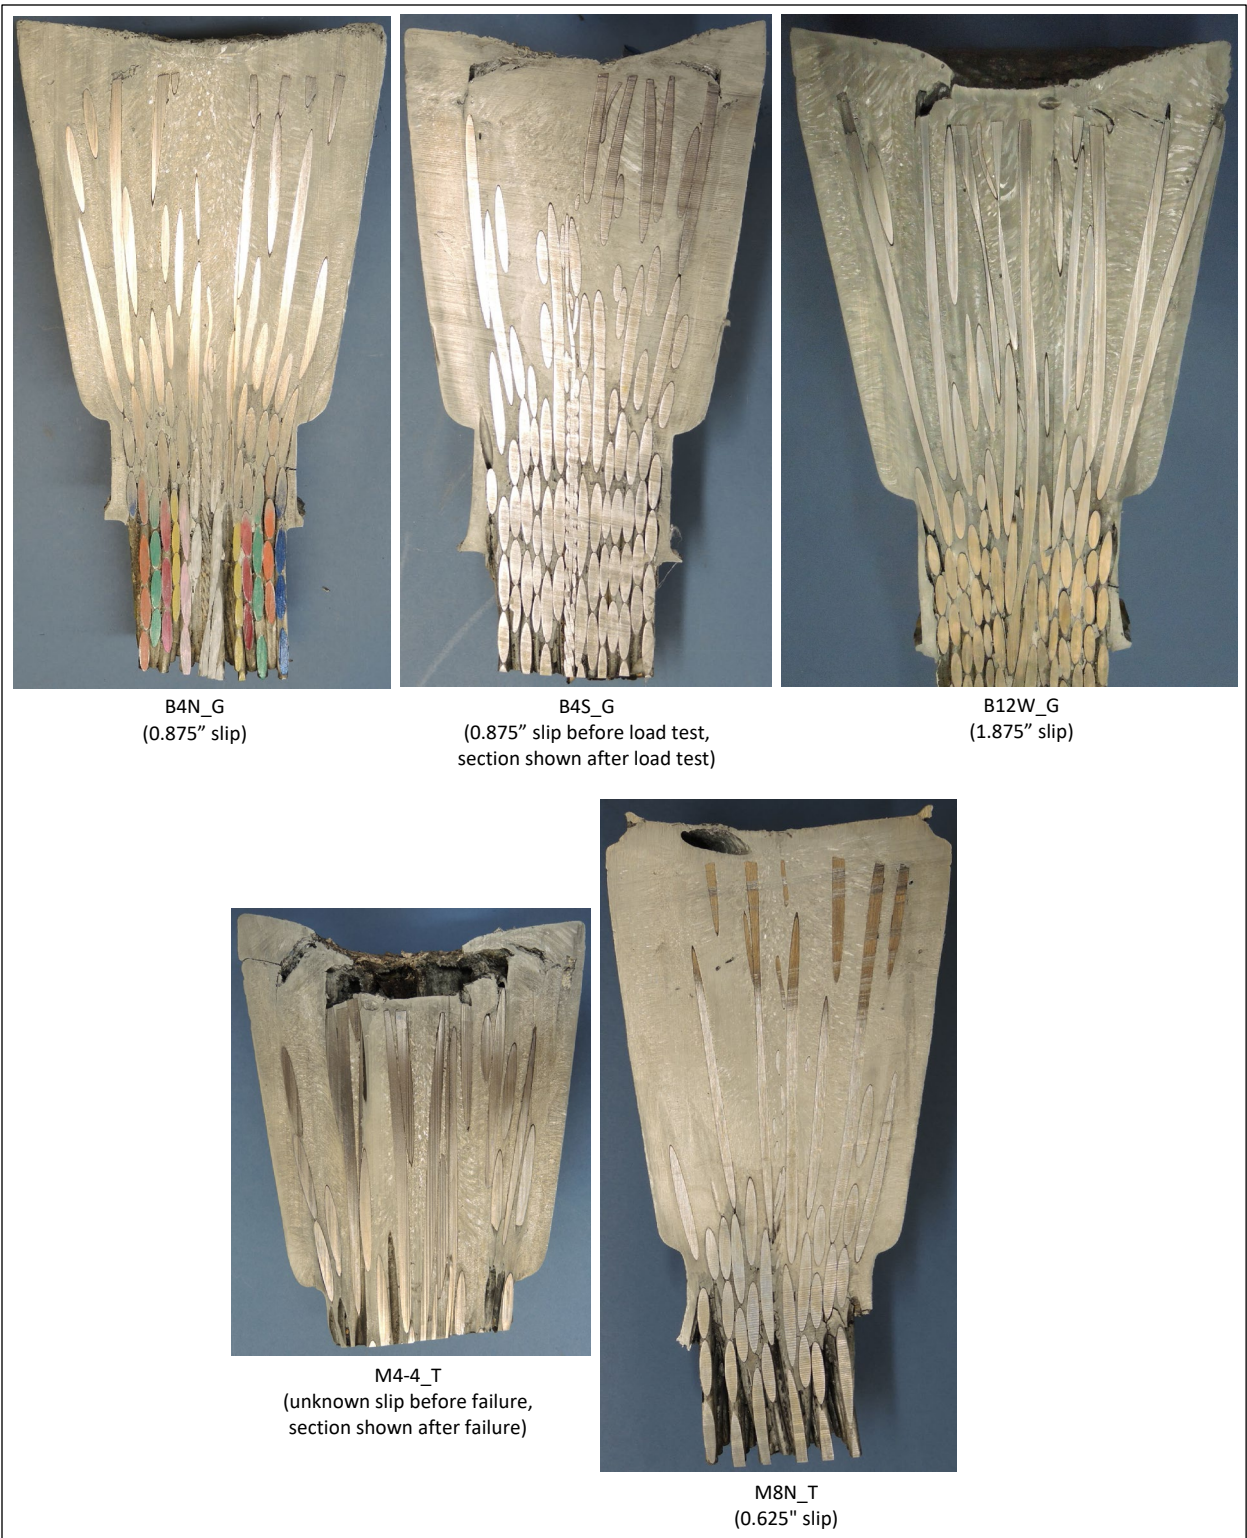
- The back surface of every casting is deformed, with a dip towards the socket's axis.
- In the castings of sockets B4S_G (failed during load test), B12W_G (maximum cable slip) and M4-4_T (failed on November 6, 2020), fracture planes developed at the back of the casting and a central core shifted in the direction of the cable pull.
- In the casting of socket B12W_G (maximum cable slip), several wires slipped with respect to the zinc outside of the displaced core.
- In the casting of M4-4_T (failed on November 6, 2020), several wires fractured inside the casting.

The core displacement and the fractured and slipped wires observed in the castings are relevant to the socket's failure modes and are further discussed in Appendix O.

Figure 11: Macro-etched transverse sections of socket zinc castings (photos: Socotec).

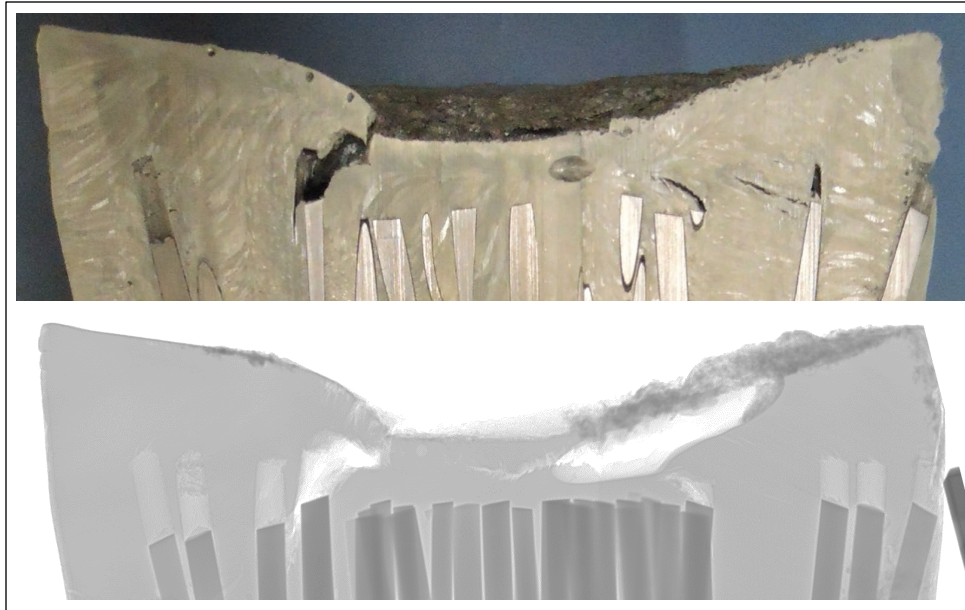
The largest cable slip was observed on socket B12W_G, and the longitudinal sectioning of that socket's zinc casting revealed that several cable wires had slipped within the casting. To determine the extent of the wire slips, we performed a neutron radiography of a one inch-thick longitudinal slice of the casting (Figure 12). The radiograph is shown in Figure 13 and reveals that within the slice considered, every wire end located outside of the displaced casting core has slipped. The wire slip distances varies from 0.4 to 0.8 inch. For comparison, we performed the same radiography on a one inch-thick slice of casting of socket M8N_T, which exhibits the smallest cable slip among the sockets considered in the laboratory studies. The radiograph is shown in Figure 14, and we observe a wire slip on only two wires, with a slip distance of less than 0.05 inch.

Figure 13: Neutron imaging of back of one inch-thick slice of B12W_G (1.875" slip) casting
(top photo: Socotec; bottom radiograph: Adrian Brügger, Columbia University - Oak Ridge National Laboratory).

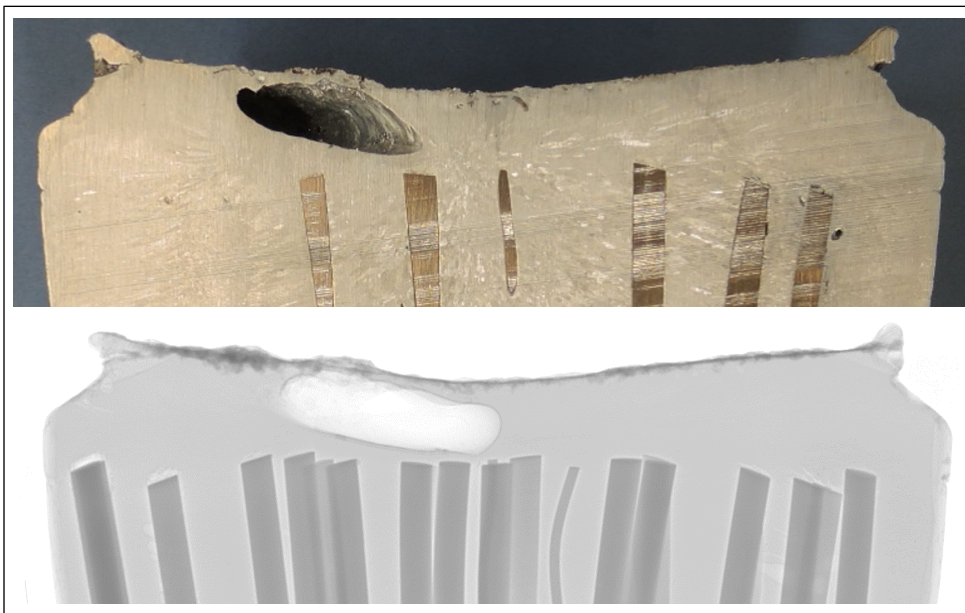
Figure 14: Neutron imaging of back of one inch-thick slice of M8N_T (0.625" slip) casting
(top photo: Socotec; bottom radiograph: Adrian Brügger, Columbia University - Oak Ridge National Laboratory).

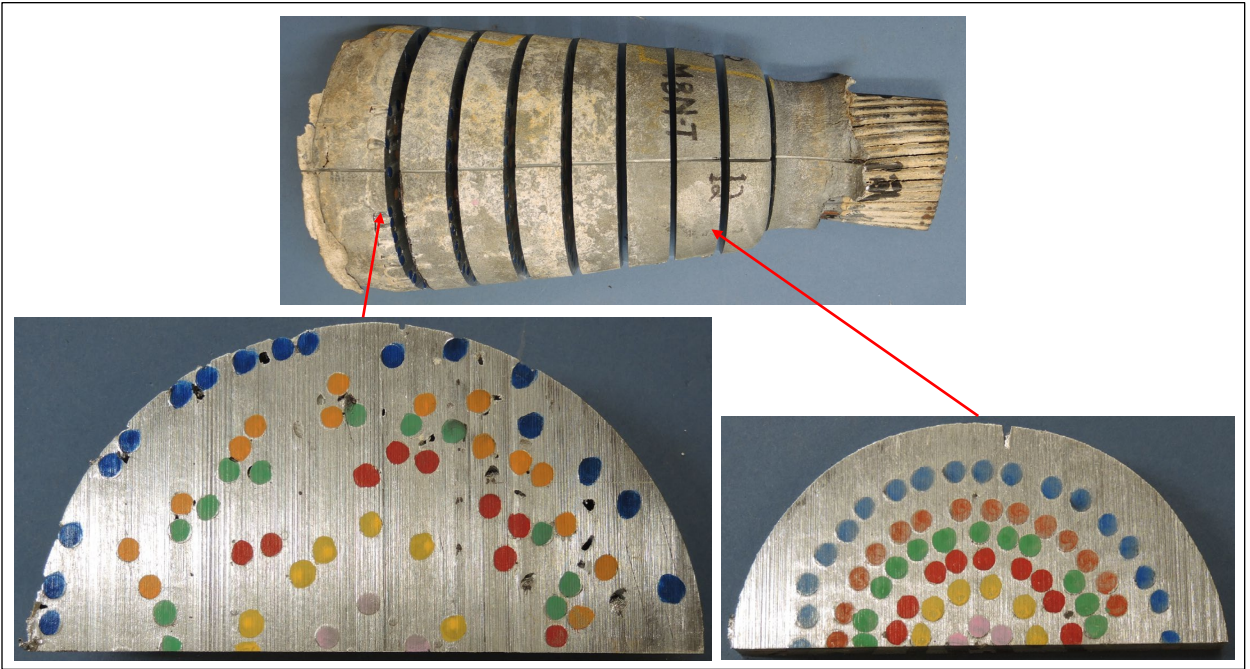
In every socket considered, the wire broom is irregular and does not follow any consistent pattern. General differences are immediately visible between the wire brooms in the sections close to the wire ends. For instance, most of the outer layer of wires is fully broomed out in socket M8N_T (Figure 17), while no wire is fully broomed-out in socket B12W_G (Figure 19). Then, the wire broom of M4-4_T (Figure 16) appears to be relatively uniform, while there is a significant zinc area with no embedded wire in socket B4N_G (Figure 18).

Figure 17: M8N_T (0.625" slip) transverse sections (photos: Socotec).

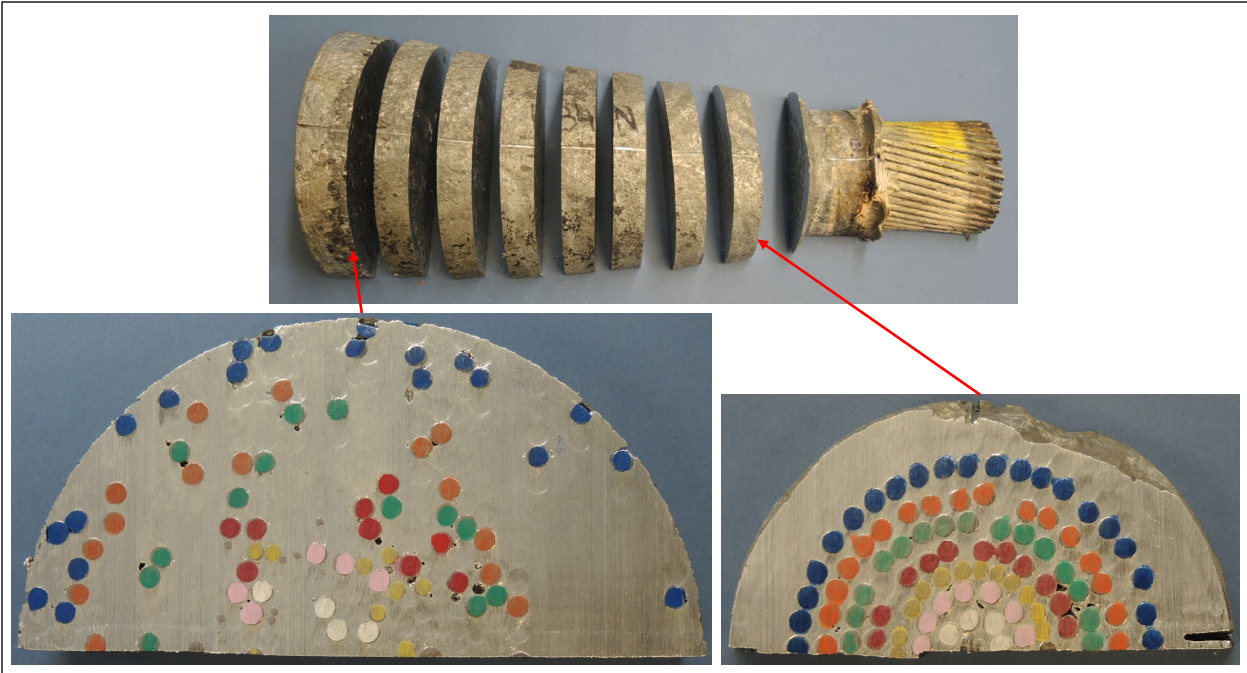
Figure 18: B4N_G (0.875" slip) transverse sections (photos: Socotec).

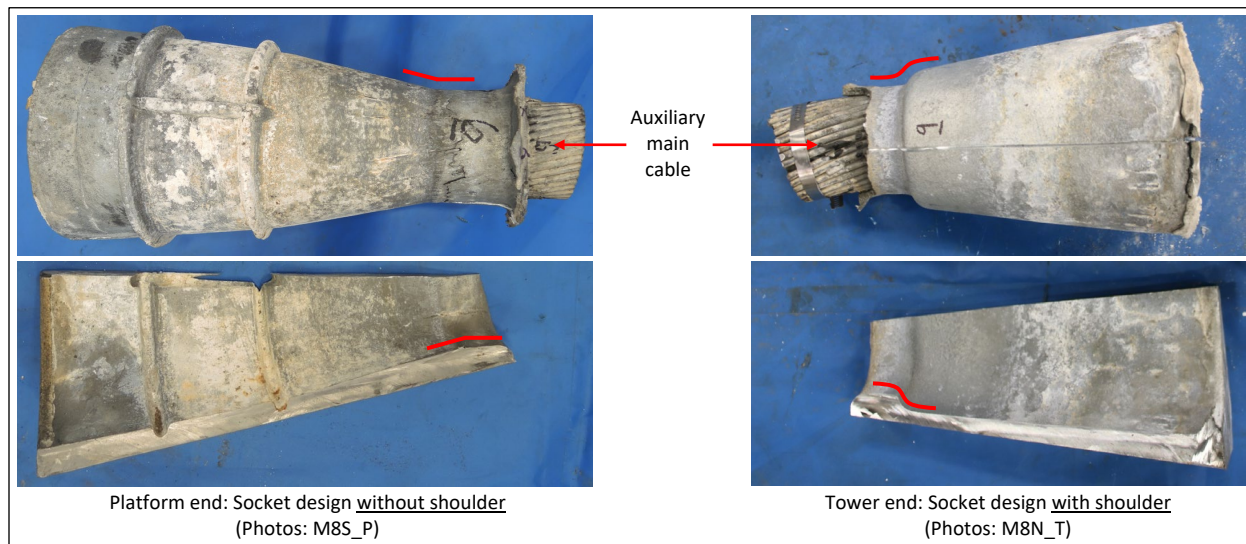
The laboratory studies revealed that these three socket designs featured a shoulder. As shown in Figure 34, the shoulder is a discontinuity in the slope of the socket's cavity near the front of the socket. However, as also shown in Figure 34, not all of the telescope's sockets had a shoulder design. The platform-end socket of an auxiliary main cable, M8N_P, was cut open by Socotec and found to not have a shoulder. The impact of the presence of a shoulder on the short-term and long-term behavior of the socket is studied in Appendix P.

Figure 34: Socket designs with and without shoulder (photos: Socotec).

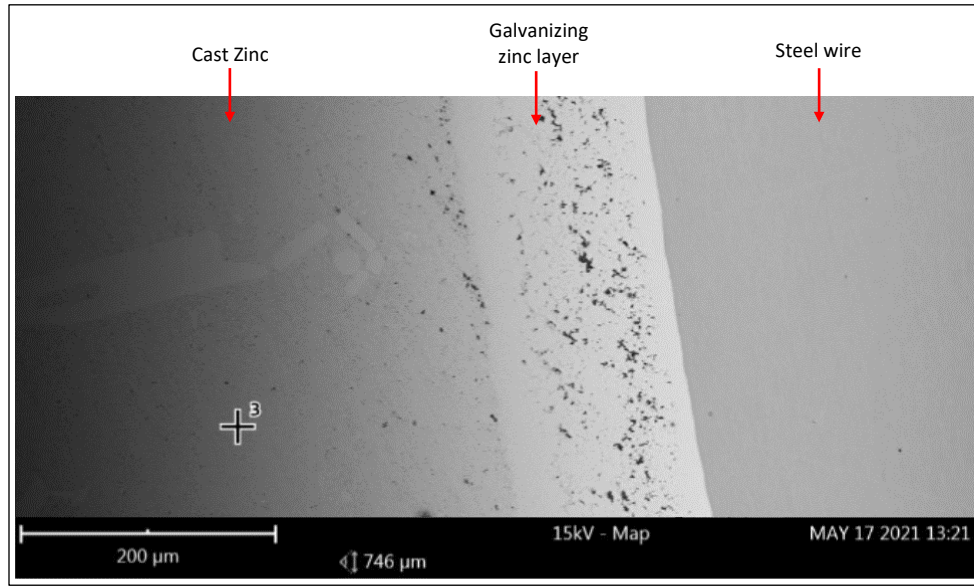
The drawings specify the cables to be galvanized structural strands based on ASTM A586, class A which requires a minimum zinc coating weight of one ounce per square foot (equivalent to a thickness of 43 micrometer). During metallographic examination of the casting of socket B4N_G, it was observed that the zinc coating had not been removed from the wires prior to socketing (Figure 35). This observation is consistent with current socketing practice.

Figure 35: Galvanizing zinc layer on wires within zinc casting (photo: Socotec).
