Appendix G

Cable Tensions during 2020 Events

1.0 Introduction

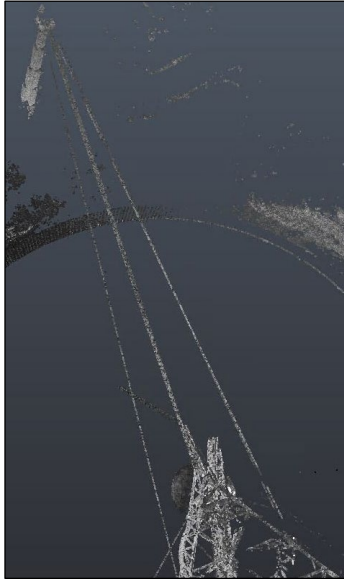
Figure 1: Tower 8 mains in August 2020 laser scan.

Each scan focuses on either the mains (Figure 1) or backstays (Figure 2) of a given tower. The scan data is a point cloud, with millions of points recreating the cable surfaces in three dimensions. Each scan was captured with the scanner set up at a fixed position. The scanner's accuracy decreases with distance, generating noisier data for the cable surfaces located further away from the scanner (Figure 3). When selecting points to measure the cable sag, we avoided the noisier surfaces when possible, and otherwise selected average points within the noise consistently along the cable.

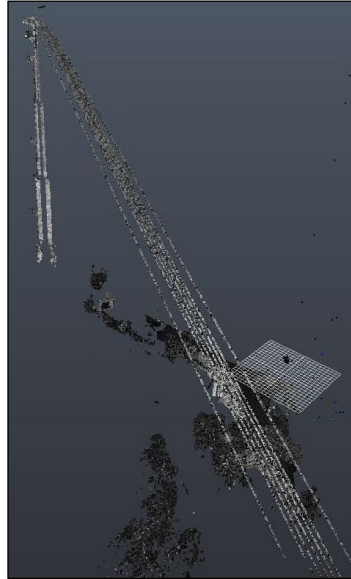
Figure 2: Tower 12 backstays in August 2020 laser scan.
