Appendix L
Cable Laboratory Analysis

After the telescope's collapse, samples were cut from the steel cables and sent to Socotec's laboratory for analysis. The objective was threefold: determine whether the cables satisfied the design requirements, evaluate the cables' condition after years of service, and investigate how some of the cables failed near the socket connections.

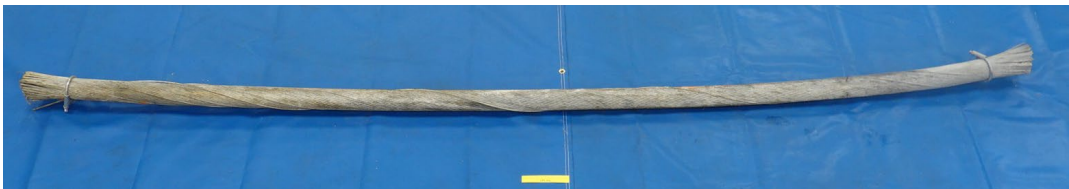
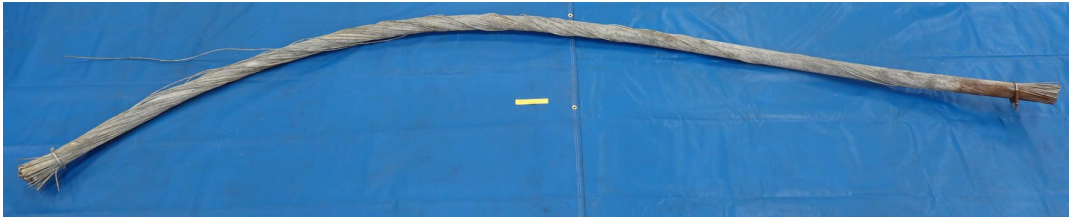
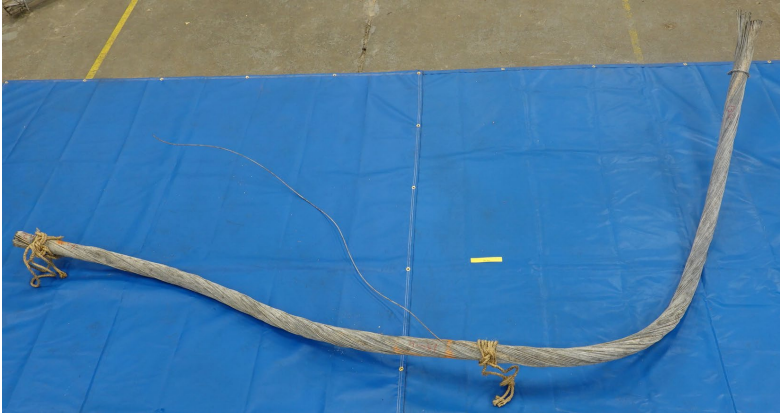
Intact cable segment 10H

Intact cable segment 11I

Intact cable segment 12G

Intact cable segment 13GH

Figure 3: Intact segments of four M4 cables (photos: Socotec).

An additional segment was cut from each of the four M4 cables and sent to Socotec's laboratory for analysis (Figure 3). Each segment was cut away from the cable failure point and had no visible wire break. These samples are referred to *intact cable segment 10H*, *11I*, *12G* and *13GH* in this appendix.
