Appendix D

Cable System Condition History

1.0 Introduction

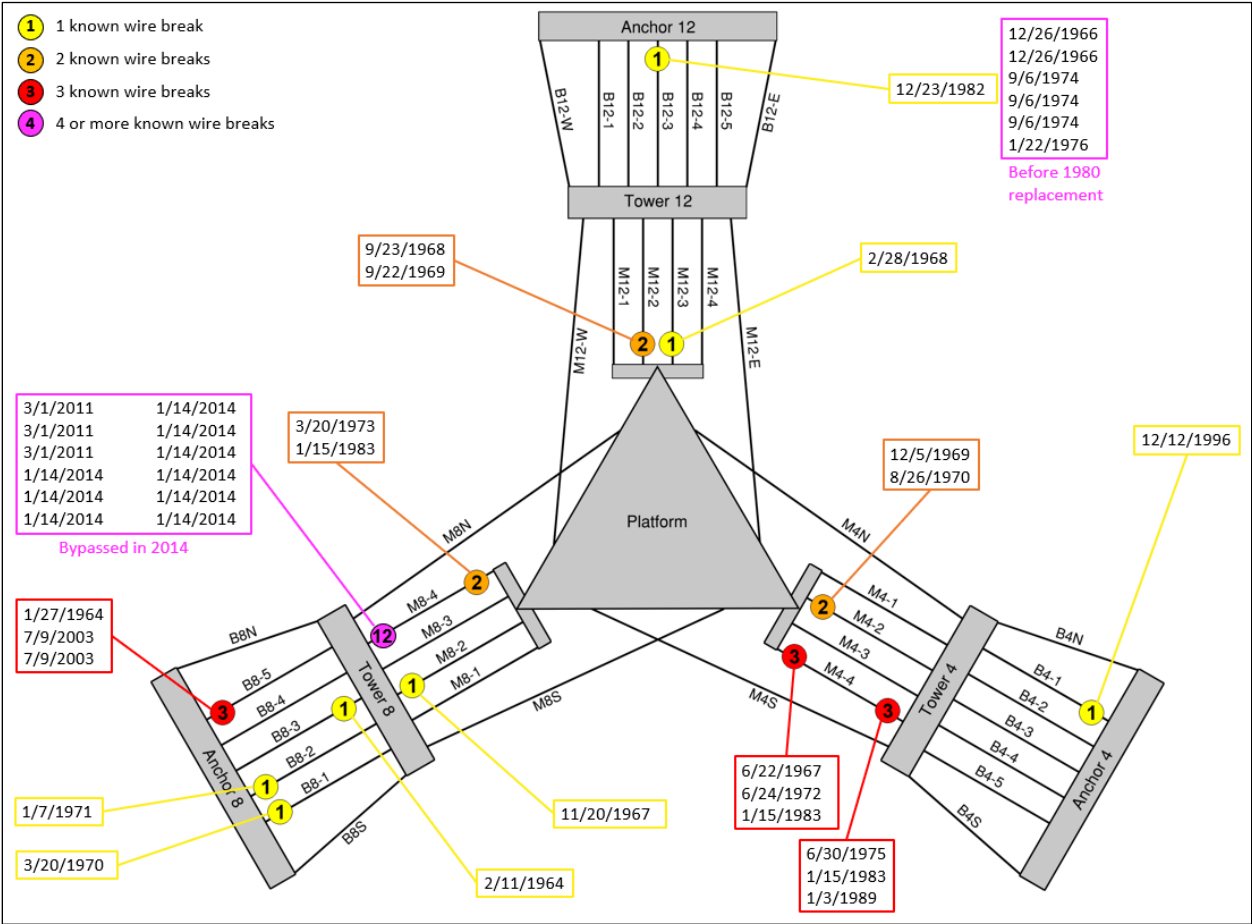
The known wire breaks before the first cable failure are mapped in Figure 13, and the number of known breaks over time is plotted in Figure 14. A map of the cable clamps and clamp marks observed in 2020 is also presented in Figure 15.

Figure 13: Known wire break locations and discovery dates before first cable failure.

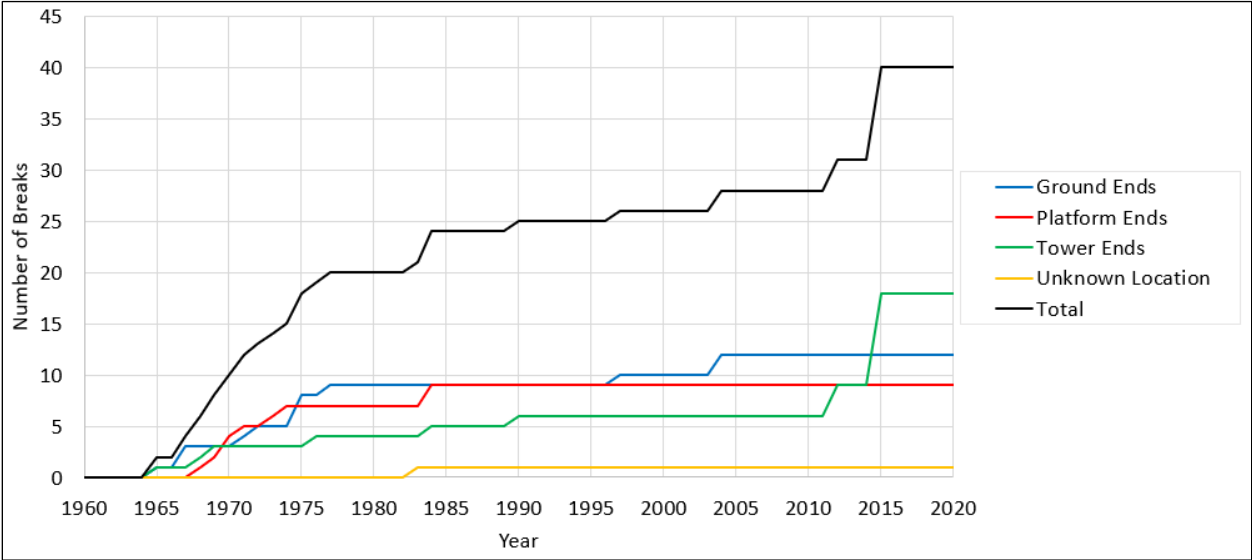
Figure 14: Count of known wire breaks up to first cable failure.

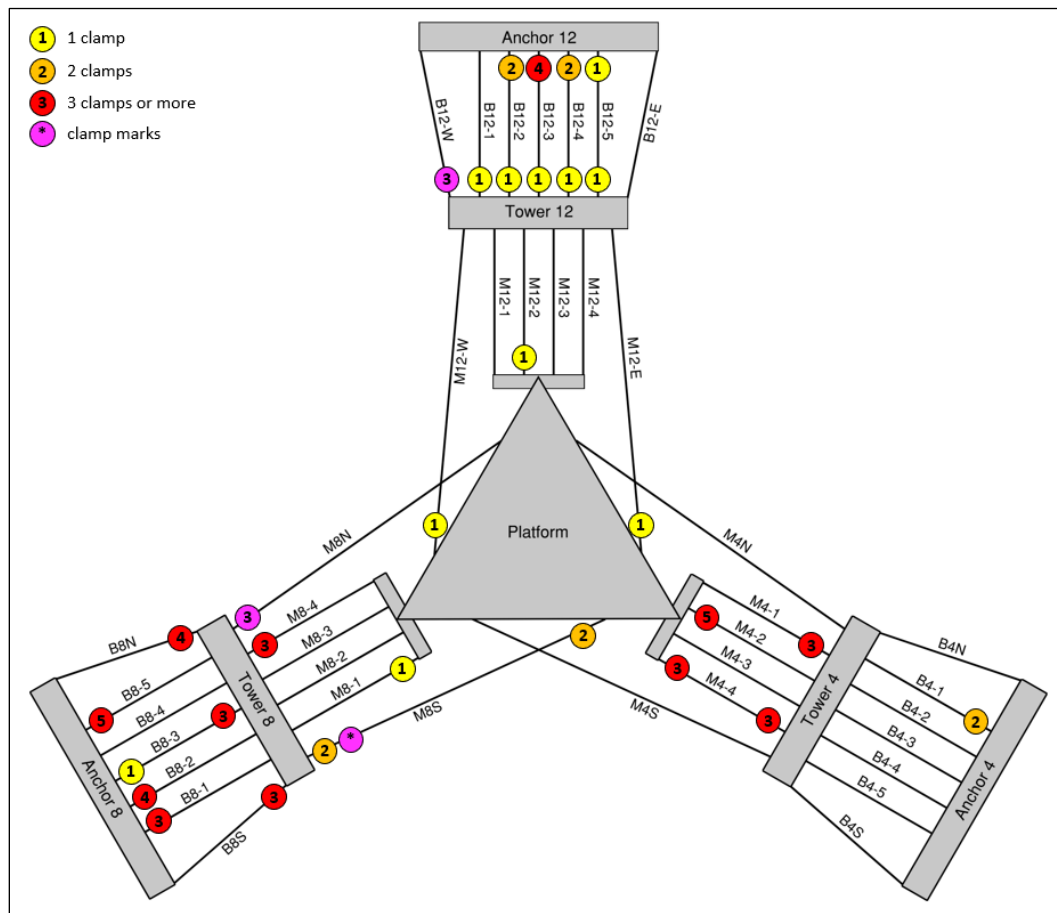
After discovering a wire break, the AO staff typically installed clamps on the cable to keep the broken wire in place. These clamps and the broken wires they hold remain visible after the cable is repainted (Figure 12). The numerous drone photos taken in 2020 after the first cable failure show evidence of past wire breaks at locations generally consistent with the breaks reported in the AO records. Past wire breaks could not be precisely counted from the drone photos, as some of the clamps appear to have been installed preventively while other clamps appear to have been removed or to have fallen from the cables.

Figure 15: Cable clamps and clamp marks observed after first cable failure.

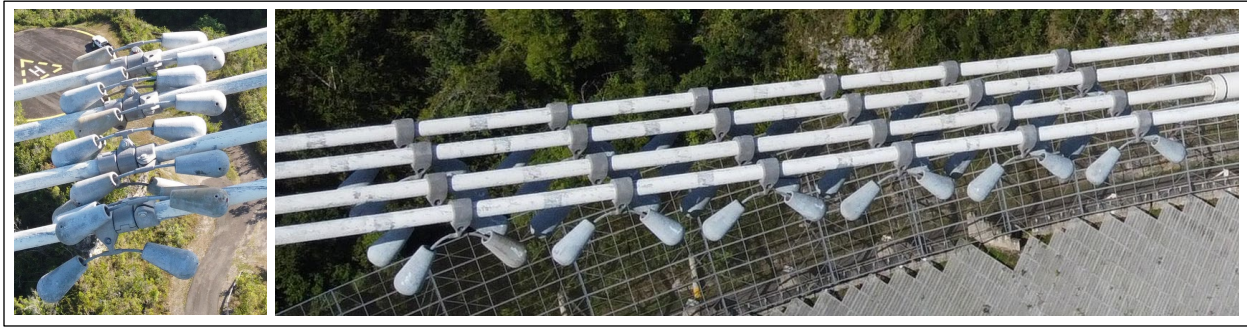
The main and backstay cables began experiencing wind-induced vibrations immediately after construction of the telescope in 1963, and Stockbridge dampers (Figure 44) were then installed to mitigate the vibrations.¹⁶ As shown in Table 3, cable vibrations continued to be reported throughout the lifespan of the telescope, which led to upgrades and adjustments of the dampers. While we have not seen any data on the amplitude of the cable movement, AW did not consider that the vibrations were a concern from a structural standpoint. The vibrations also appear to have been relatively infrequent and may have occurred only under specific wind conditions. Finally, the initial installation and later adjustments of the damper system appear to have been effective.

Figure 44: Stockbridge dampers near top (left) and bottom (right) of original M4 cables in 2020
(photos: NAIC Arecibo Observatory, a facility of the NSF).
