Appendix M
Socket Laboratory Analysis

The cables of the telescope were terminated with zinc-filled spelter sockets, which are commonly used to connect large structural cables. The first and second cable failures in 2020 occurred near or within the sockets at the top of Tower 4, and significant cable slips were observed on other sockets before and after the cable failures. The behavior and failure of the sockets is therefore a focus of our investigation, and several sockets were recovered from the collapsed structure and analyzed in laboratories. The results of the laboratory analyses are presented in this appendix, which is organized by type of laboratory test.

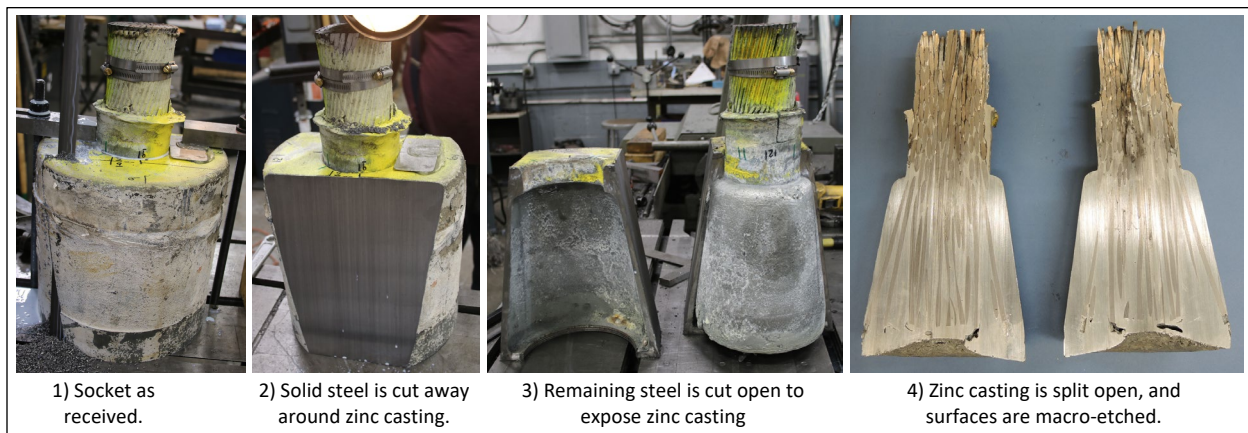
Figure 10: Initial processing of socket B12W_G (photos: Socotec).

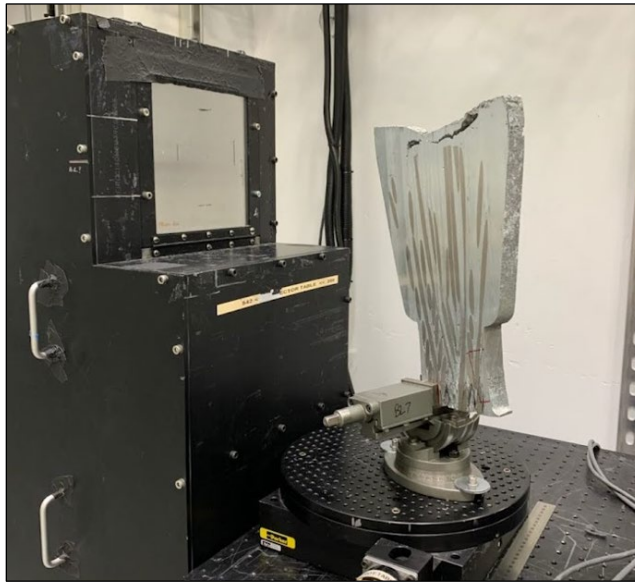
The largest cable slip was observed on socket B12W_G, and the longitudinal sectioning of that socket's zinc casting revealed that several cable wires had slipped within the casting. To determine the extent of the wire slips, we performed a neutron radiography of a one inch-thick longitudinal slice of the casting (Figure 12). The radiograph is shown in Figure 13 and reveals that within the slice considered, every wire end located outside of the displaced casting core has slipped. The wire slip distances varies from 0.4 to 0.8 inch. For comparison, we performed the same radiography on a one inch-thick slice of casting of socket M8N_T, which exhibits the smallest cable slip among the sockets considered in the laboratory studies. The radiograph is shown in Figure 14, and we observe a wire slip on only two wires, with a slip distance of less than 0.05 inch.

Figure 12: one inch-thick slide of B12W_G (1.875" slip) casting held in neutron imaging scanner
(photo: Adrian Brügger, Columbia University - Oak Ridge National Laboratory).

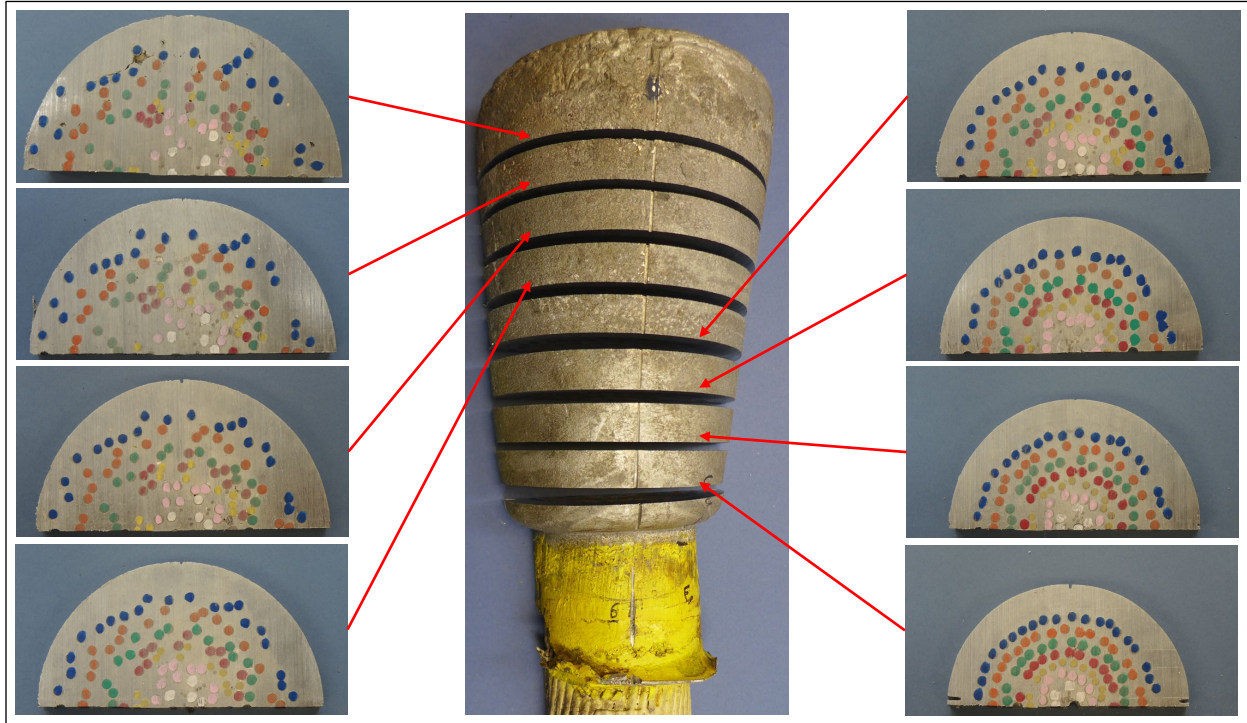
The zinc castings were sectioned in the transverse direction to observe the wire distribution within the casting, which is referred to as the wire broom. As shown in Figure 15, in some of the castings the wires were traced through multiple transverse sections and color-coded based on the layer that they belonged to in the cable.

Figure 15: Transverse sections and wire layer tracing in B12W-G (1.875" slip) zinc casting (photos: Socotec).

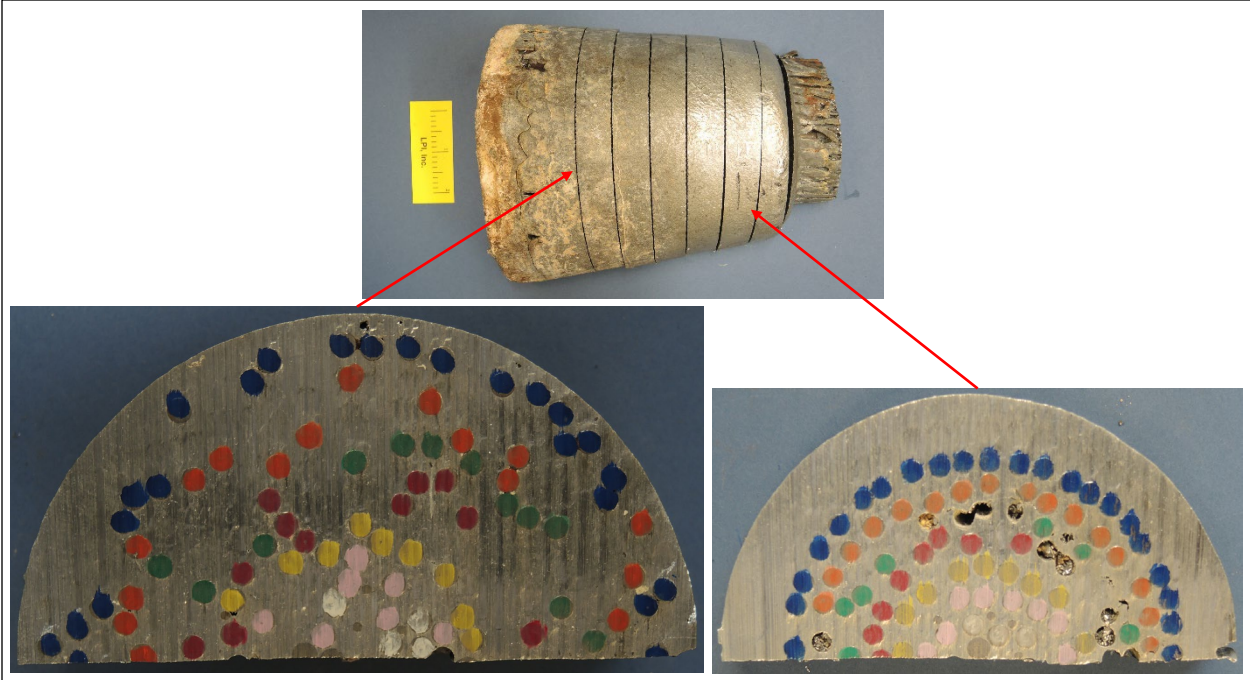
Figure 16: M4-4_T transverse sections (photos: Socotec).

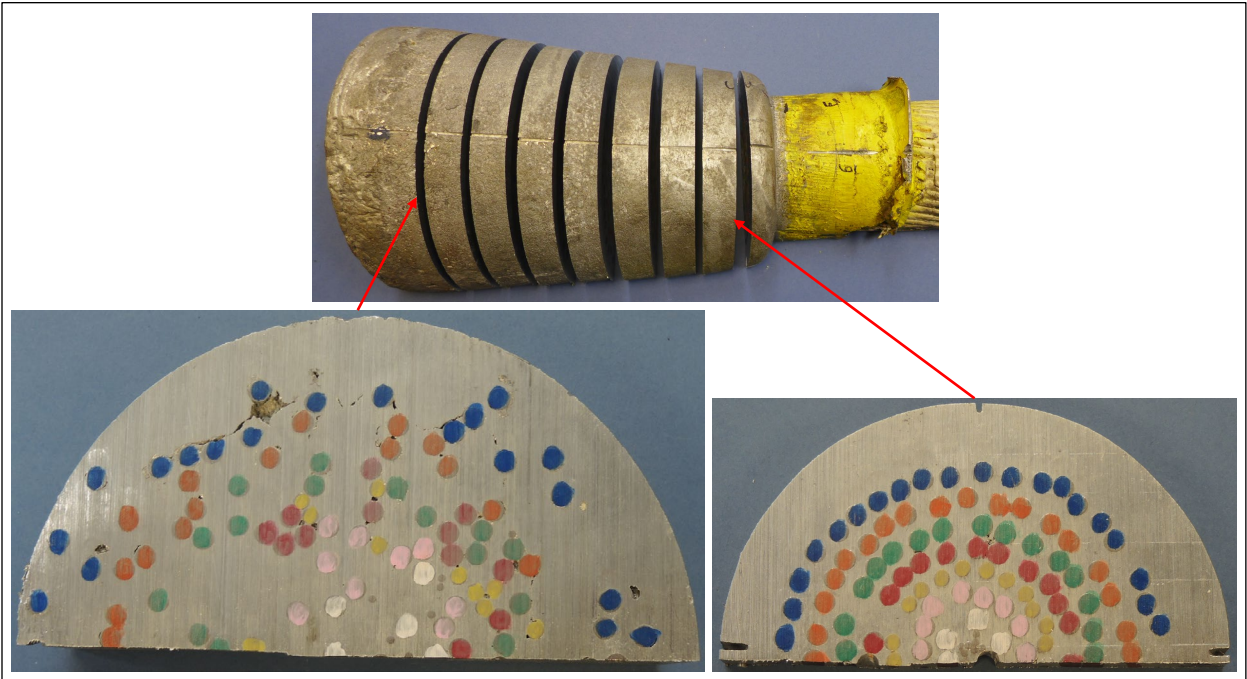
In every socket considered, the wire broom is irregular and does not follow any consistent pattern. General differences are immediately visible between the wire brooms in the sections close to the wire ends. For instance, most of the outer layer of wires is fully broomed out in socket M8N_T (Figure 17), while no wire is fully broomed-out in socket B12W_G (Figure 19). Then, the wire broom of M4-4_T (Figure 16) appears to be relatively uniform, while there is a significant zinc area with no embedded wire in socket B4N_G (Figure 18).

Figure 19: B12W_G (1.875" slip) transverse sections (photos: Socotec).

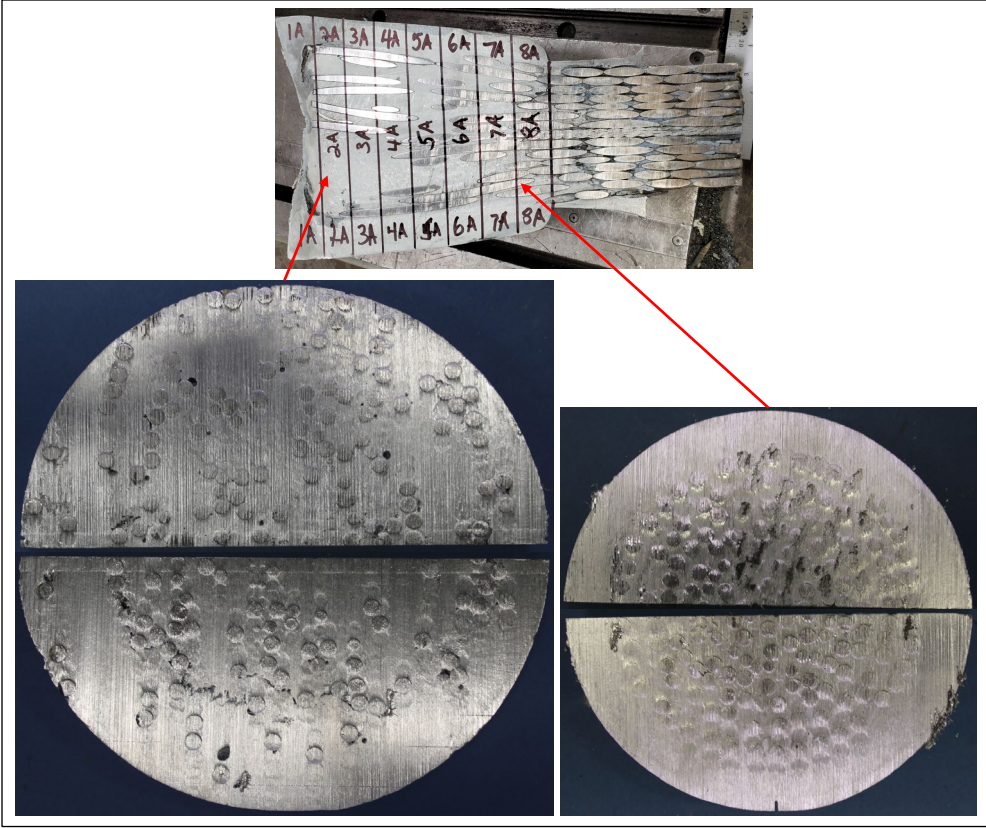
Figure 20: B4S_G (0.875" slip) transverse sections (photos: Socotec).

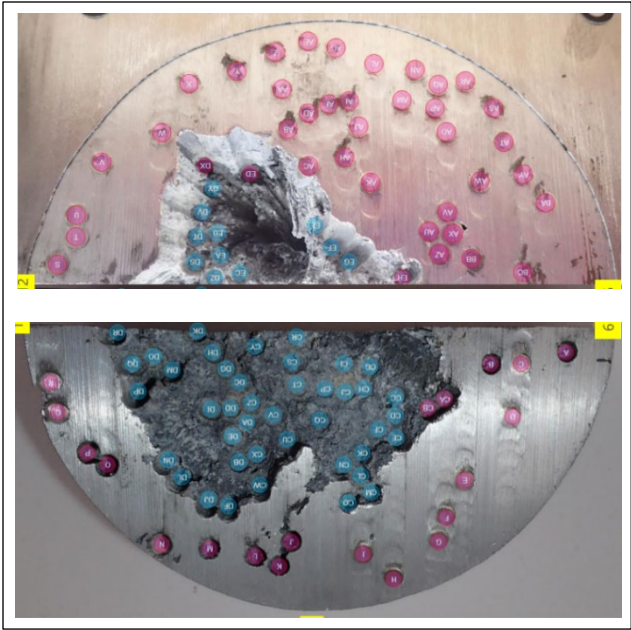
Figure 21: Wire locations at back of M4N_T (1.125" slip) (photos: WJE²).

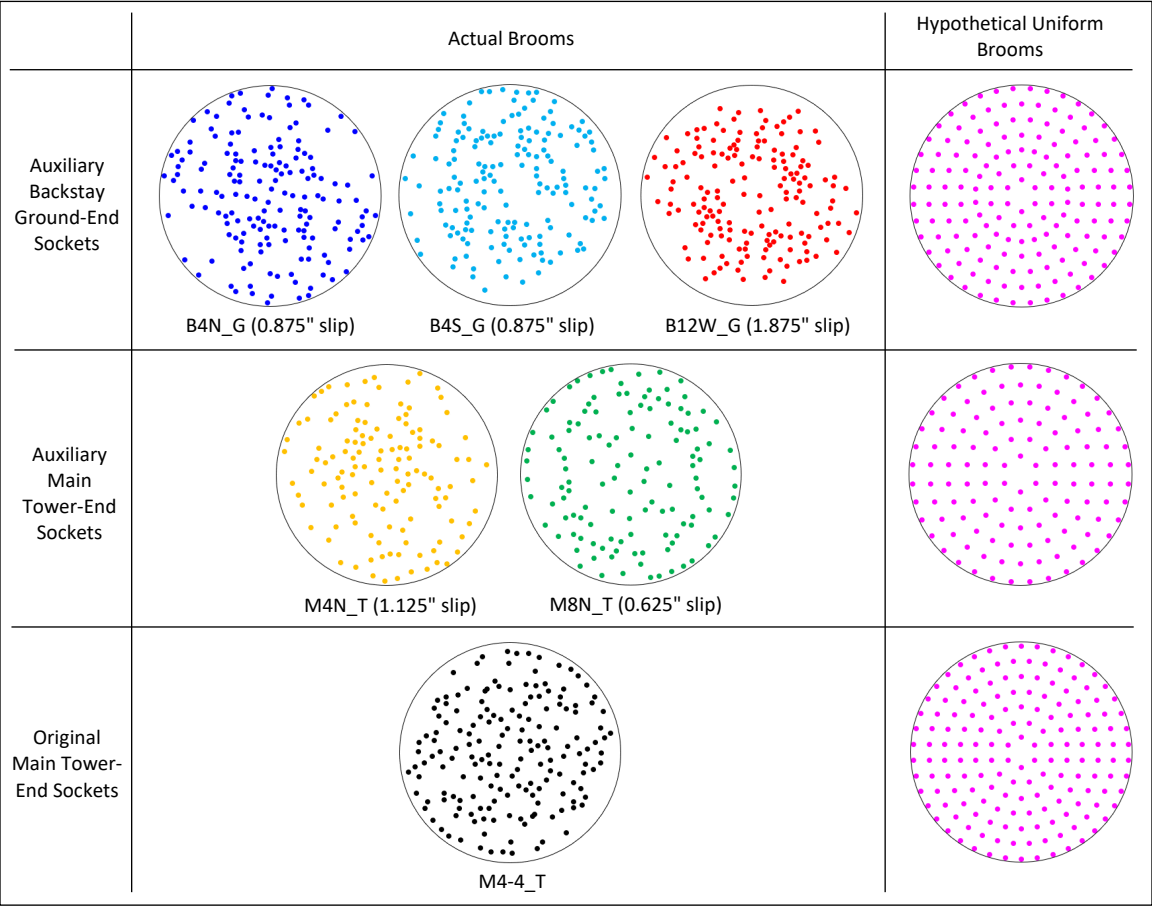
The wire end distribution are shown in Figure 22 for the six socket castings considered. When the broom was observed on only half of the casting, the wire distribution was mirrored in the other half. For each type of socket, the actual brooms are compared to a hypothetical uniform broom where the wires are evenly-spaced in the radial and circumferential directions.

Figure 22: Wire end distribution at back of actual brooms and in hypothetical uniform brooms.

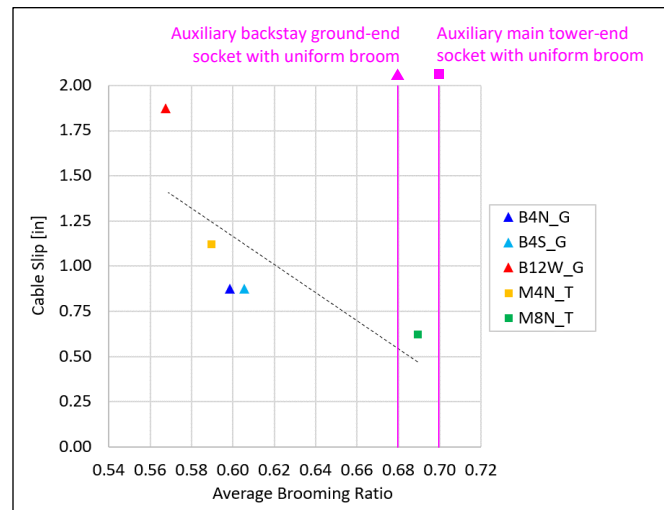
For the five sockets whose cable slips are known, the average brooming ratio is plotted against cable slip in Figure 24. We observe a general correlation, with the cable slip decreasing as the brooming ratio increases. Due to the limited number of data points, this correlation is not sufficient to draw a conclusion on the impact that the wire broom many have on the cable slips. The potential ties between wire broom and cable slip were further investigated through calculations presented in Appendix O. We also observe that socket M8N_T, which exhibits the smallest cable slip, is the only socket whose average brooming ratio is similar to the ones of the uniform brooms.

Figure 24: Wire average relative distance to center vs. cable slip.

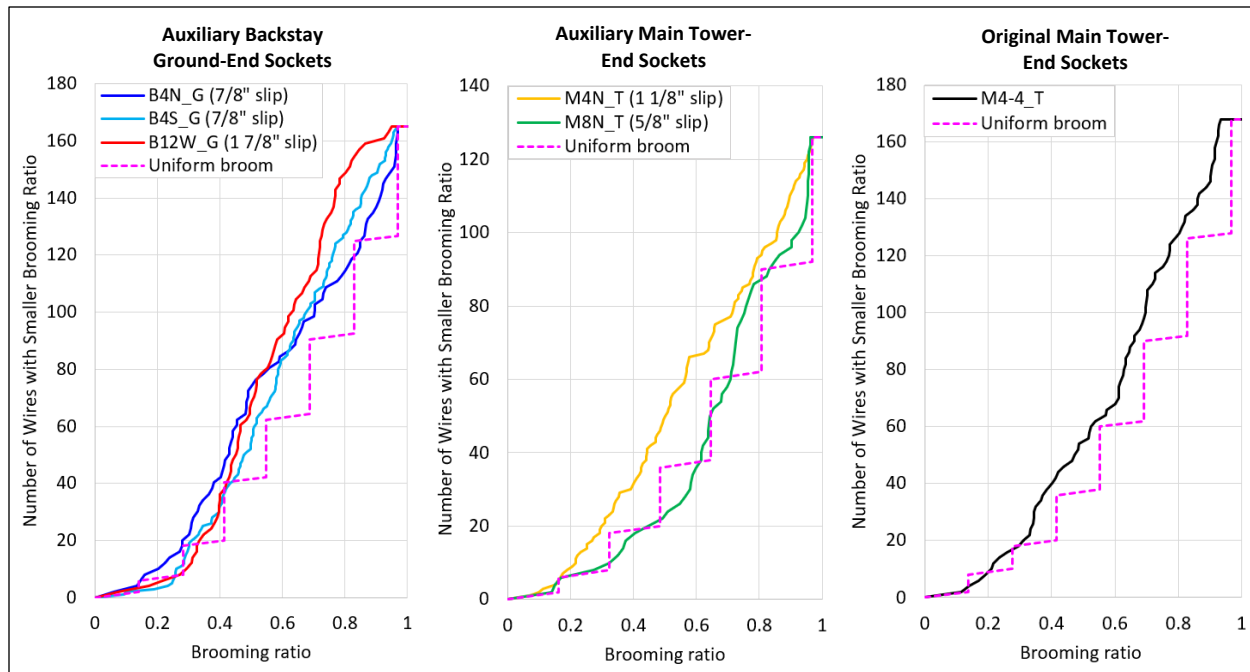
The cumulative distribution of the wire brooming ratios in each socket and in the uniform brooms are shown in Figure 25. For the uniform brooms, the distribution has discontinuities because the wires ends are assumed to remain in concentric layers.

Figure 25: Cumulative distribution of wire brooming ratios.

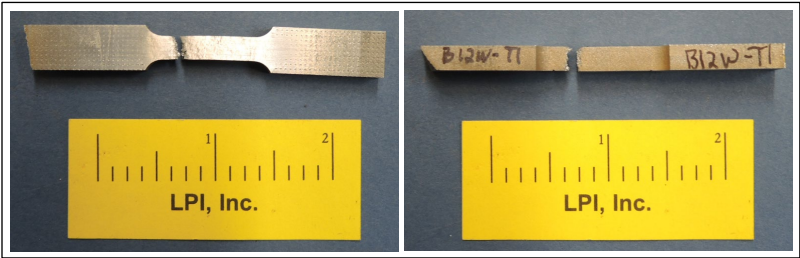
Figure 27: Zinc sample B12W_G-F after tensile testing to failure (photos: Socotec).

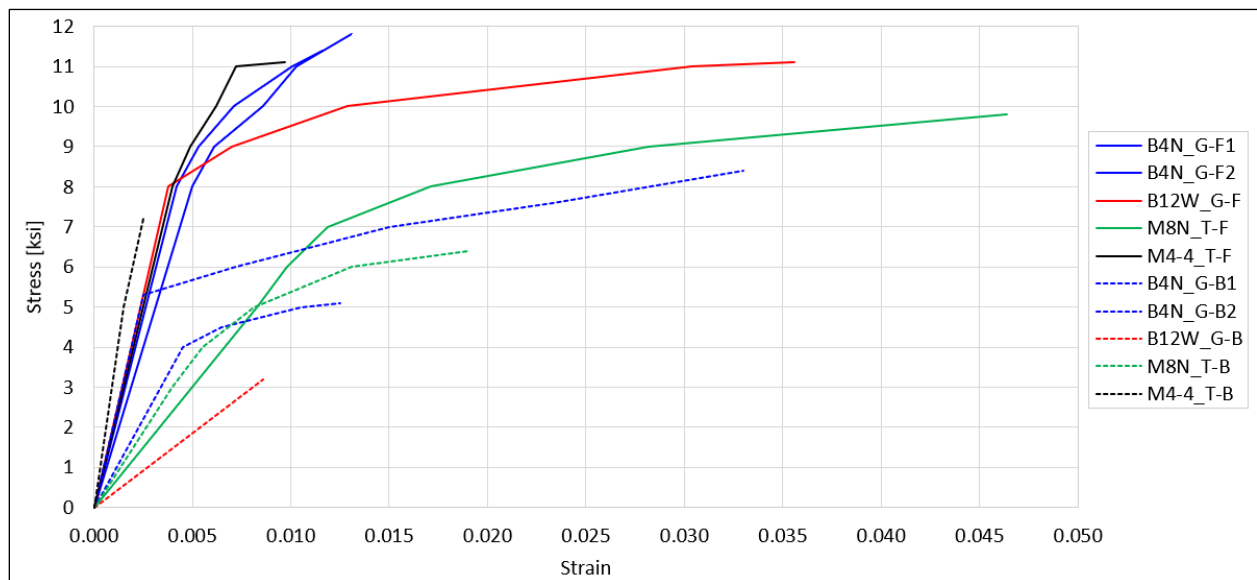
The results of the tensile tests are presented in Figure 28 as stress-strain curves up to the ultimate tensile stress reached. We first observe a wide range of ultimate tensile stress across the specimens, between three kilopound per square inch (ksi) and 12 ksi. The ultimate tensile stress is also reached for a wide range of strains. For every casting, the ultimate tensile stress is higher in the specimen(s) taken from the front of the casting than the specimen(s) taken from the back. This is consistent with the larger grain sizes observed at the back of the sockets, as described in (section 7.3 below).

Figure 28: Strain-stress curves from tensile test results, up to ultimate stress.

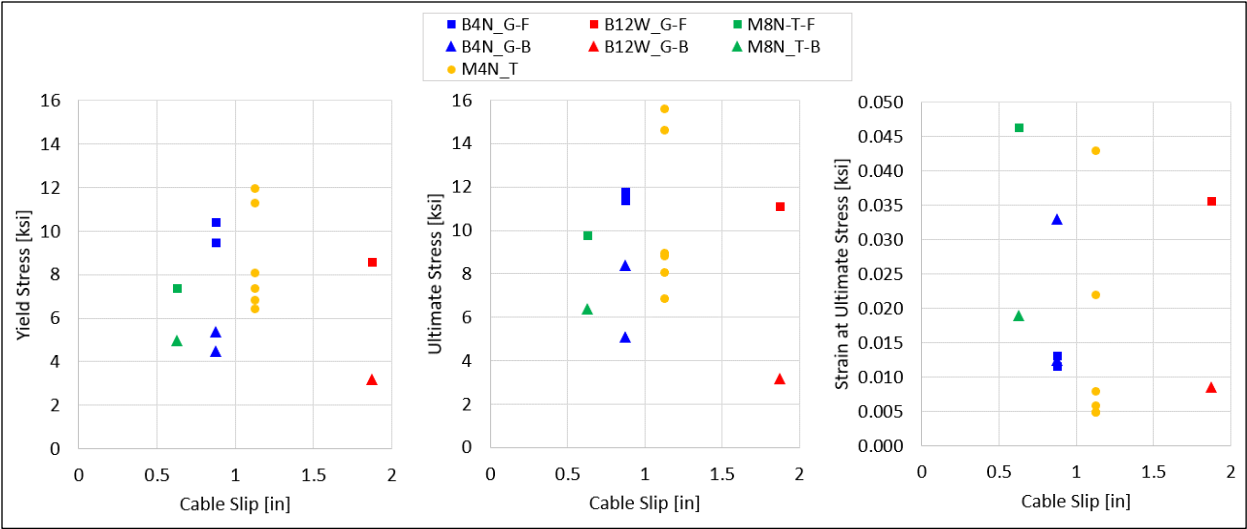
For the three sockets whose cable slips are known, the tensile test results (yield stress, ultimate tensile stress, and strain at ultimate tensile stress) are plotted against cable slip in Figure 29. WJE-NESC performed tensile tests on the zinc of socket M4N_T, and the results provided in their report are added to the plots. We observe no correlation between cable slip and the tensile properties of the zinc.

Figure 29: Zinc tensile test results vs. cable slip.

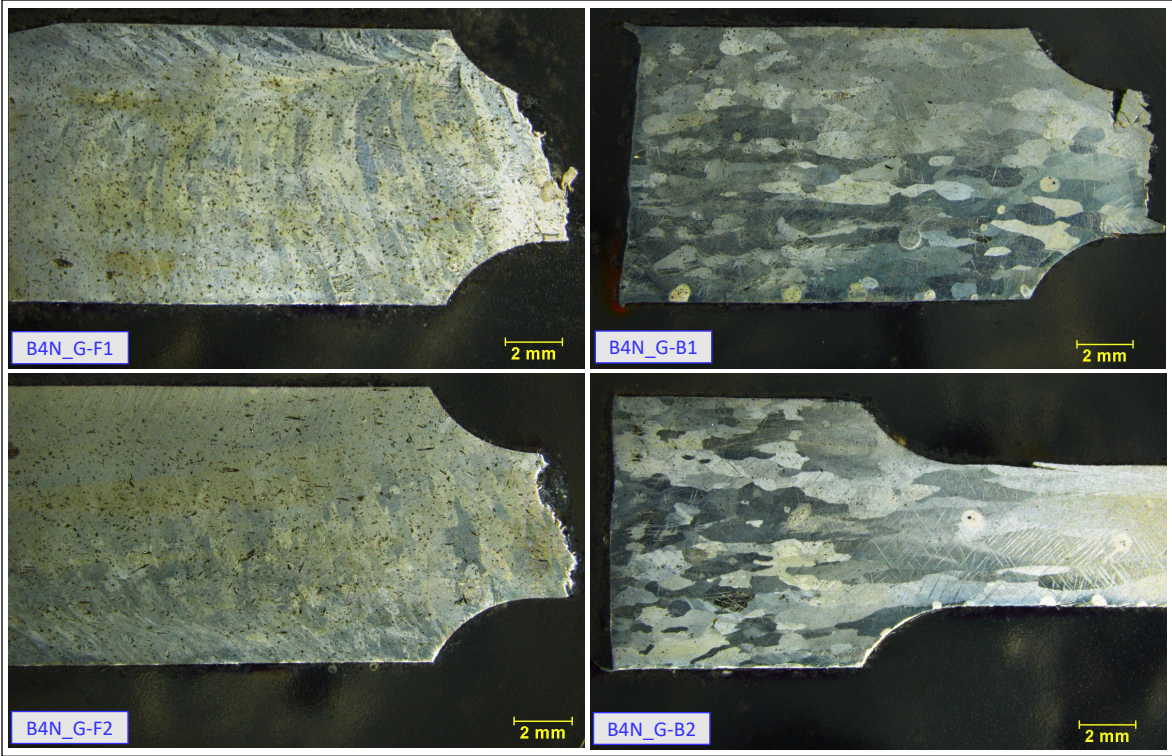
The zinc specimens cut from the socket castings and tested in tension were prepared for metallographic observation. The results are shown in Figure 30 to Figure 33, with each figure comparing the grain structure of the sample(s) taken at the front and back of a given casting. In every casting, the grains are smaller at the front of the casting and larger at the back. This is consistent with the tensile test results, where higher yield and ultimate tensile stresses were measured at the front of the casting. The smaller grain size is likely due to the faster cooling of the molten zinc at the front of the casting during the socketing process.

Figure 30: Grain size comparison between tensile specimens of socket B4N_G (photos: Socotec).

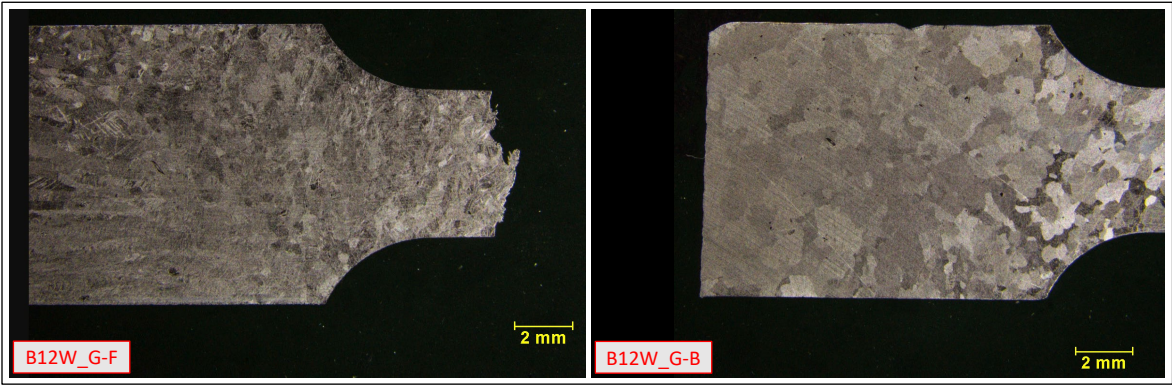
Figure 31: Grain size comparison between tensile specimens of socket B12W_G (photos: Socotec).

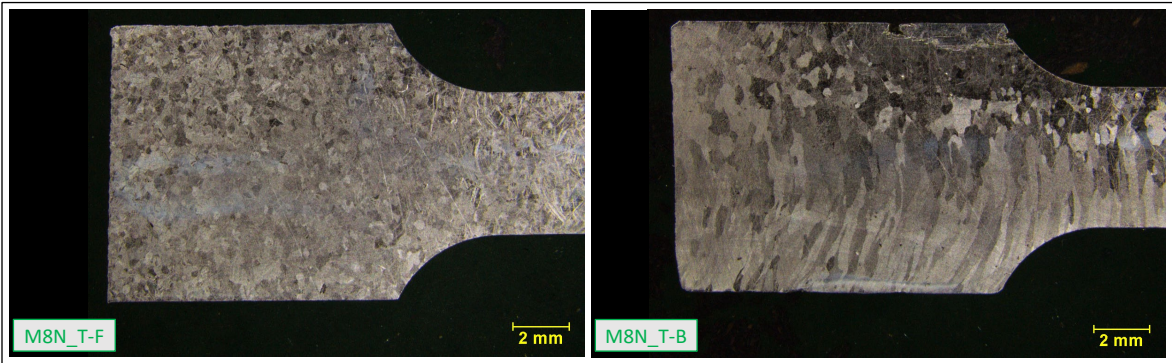
Figure 32: Grain size comparison between tensile specimens of socket M8N_T (photos: Socotec).

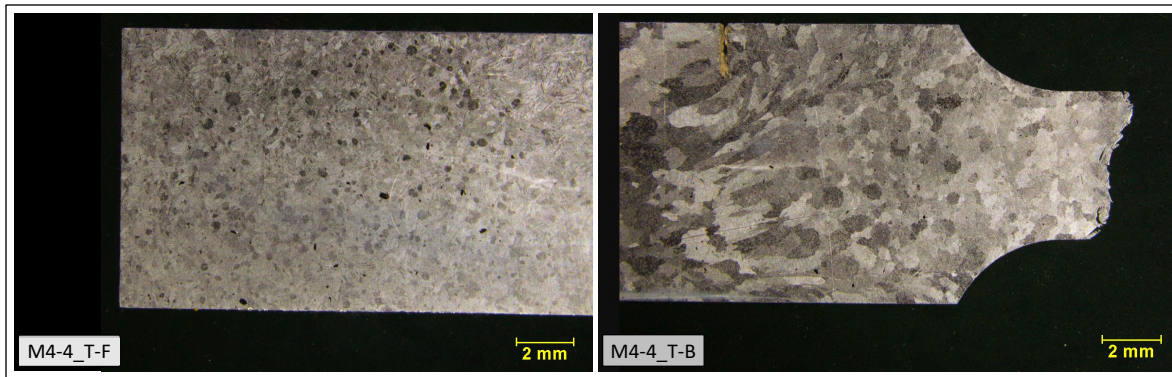
Figure 33: Grain size comparison between tensile specimens of socket M4-4_T (photos: Socotec).
